CENTRAL VALLEY REGIONAL WATER QUALITY CONTROL BOARD

INSPECTION REPORT

DISCHARGER: Walker Mine

INSPECTION DATE: 10 October 2007

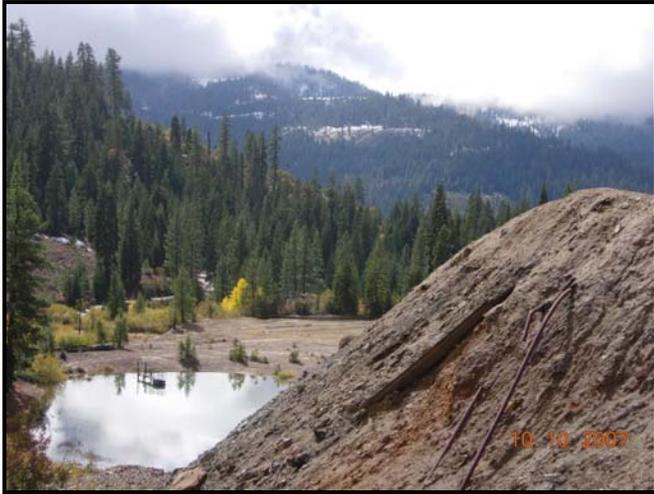
#1. Walker Mine, Plumas County October 2007.

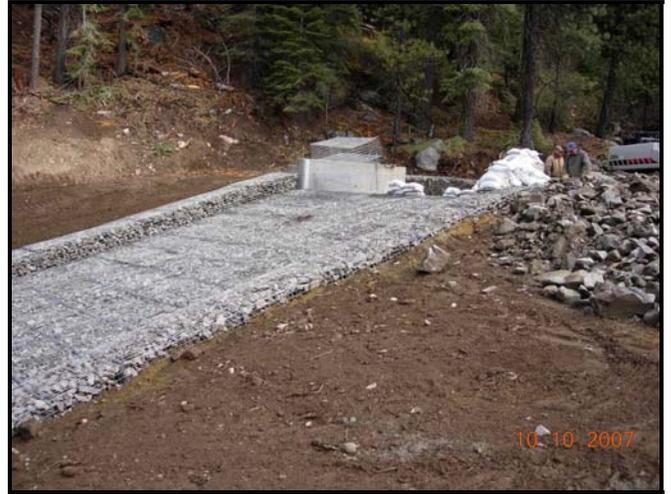
Construction of the diversion channel infrastructure was nearly complete as shown in Photos #2-11. However, the USFS project engineer (George Butler, Plumas National Forest) indicated that a significant amount of subsurface drainage from hillsides surrounding the tailings site is making its way into the tailing site, surfacing in the old Dolly Creek channel, and discharging at the USFS dam location as shown in photos #12-13. This was not entirely anticipated by the USFS and will need to be further assessed in order to reduce metals discharged into Little Grizzly Creek.

#4. Drop structure above the tailings impoundment.

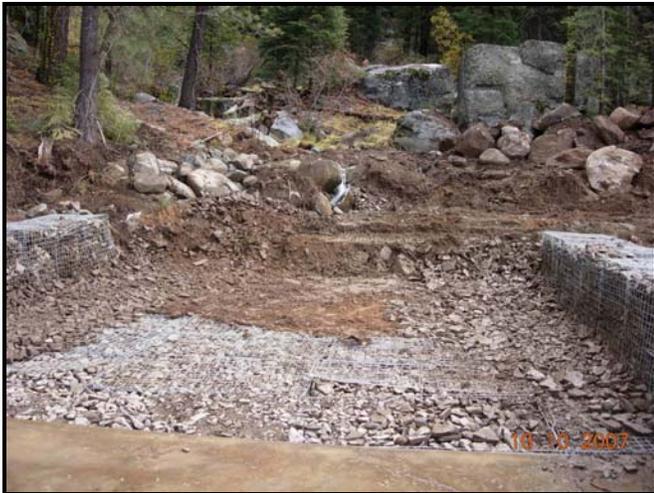
#2. USFS Dolly Creek diversion work. Inlet structure located above the tailings impoundment.

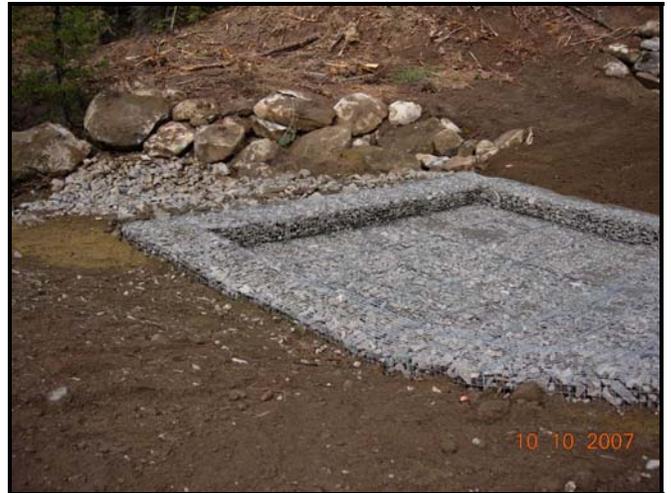
#5. Stilling basin located at the base of the drop structure.

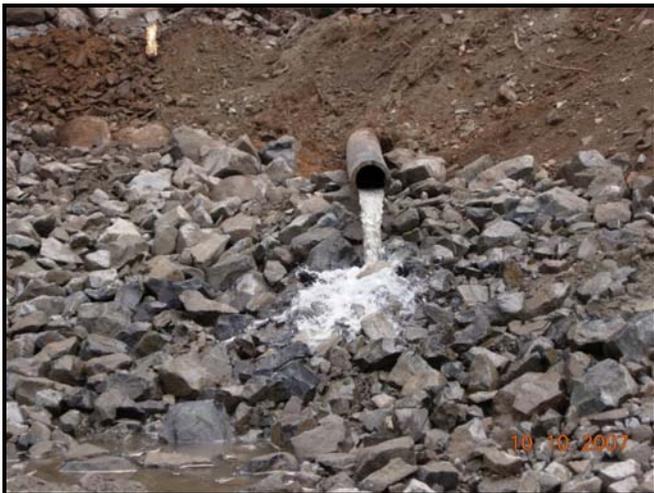
#3. Dolly Creek temporary diversion.

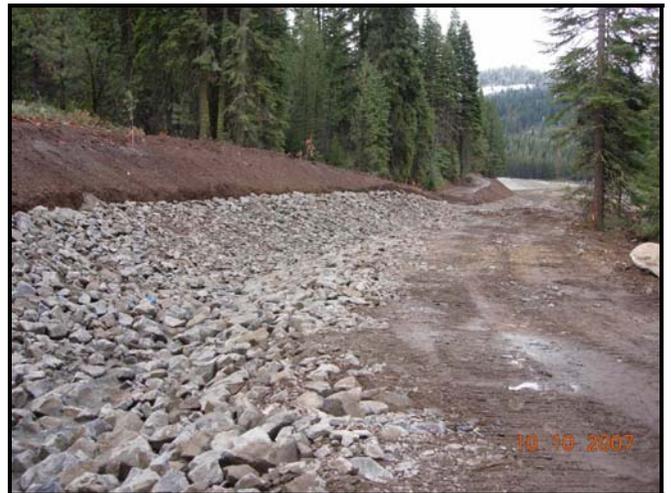
#6. Dolly Creek upper diversion channel looking downgradient towards the tailings impoundment.

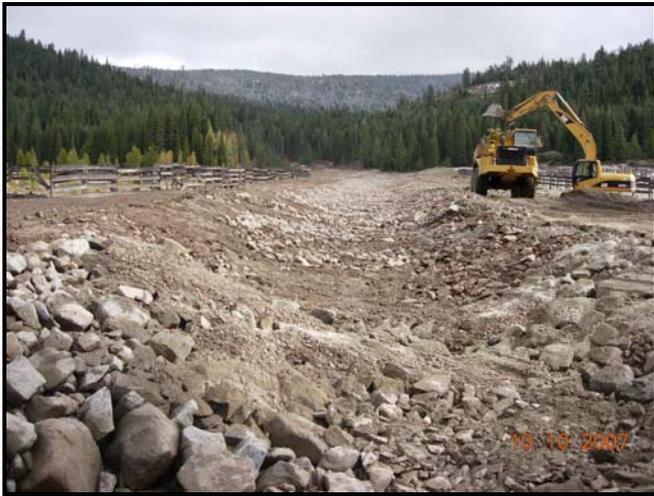
#7. Dolly Creek lower diversion channel looking upgradient towards Walker Mine.

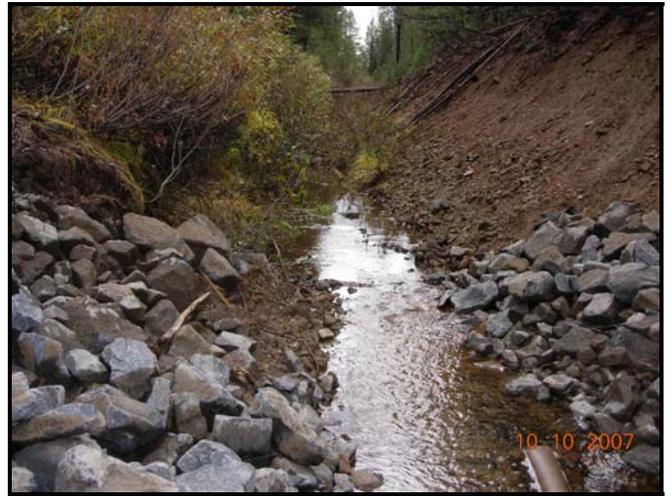
#10. Little Grizzly Creek looking upstream from the confluence with Dolly Creek.

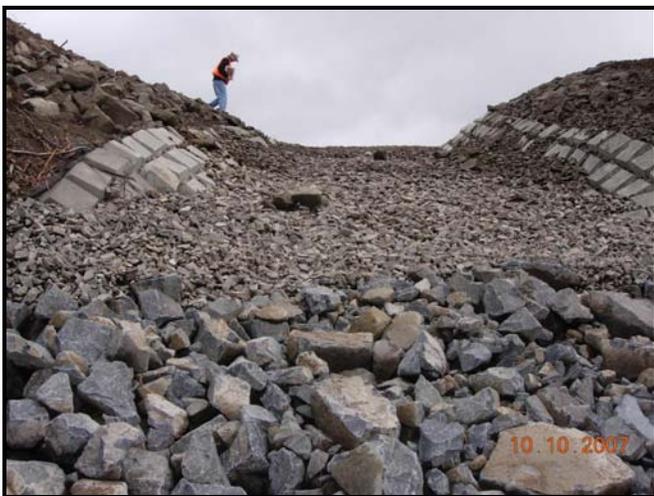
#8. New tailings impoundment outfall structure from Dolly Creek to Little Grizzly Creek looking upgradient.

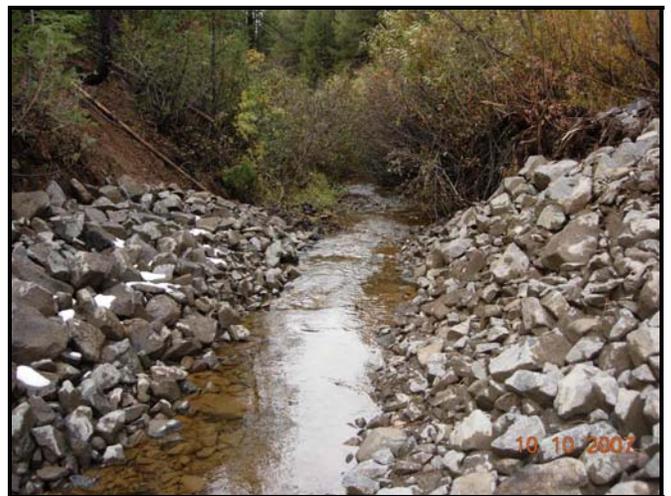
#11. Little Grizzly Creek looking downstream from the confluence with Dolly Creek.

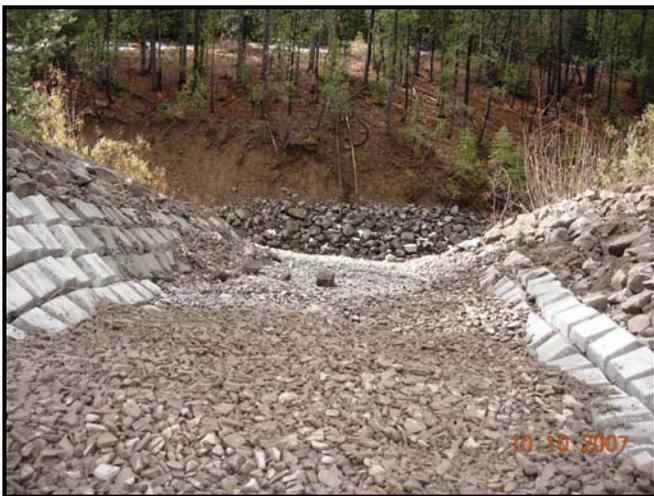
#9. New tailings impoundment outfall structure from Dolly Creek to Little Grizzly Creek.

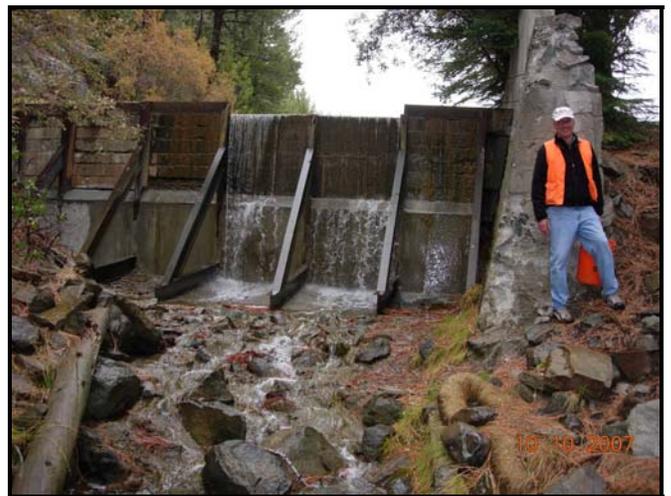
#12. Existing USFS tailings impoundment dam on Dolly Creek.

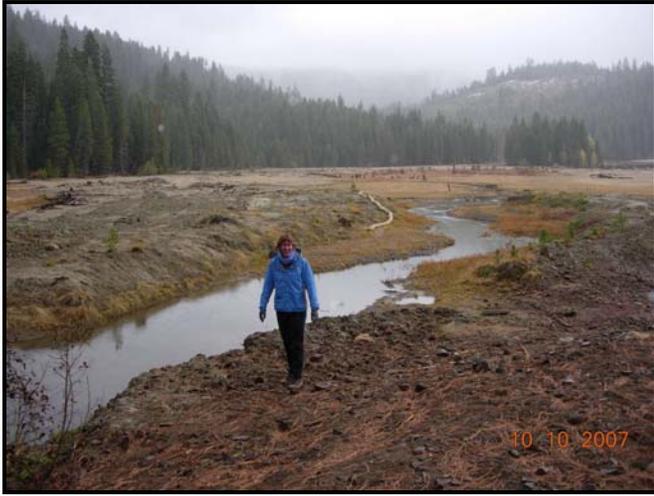
#13. Looking upgradient at Dolly Creek near the USFS dam.

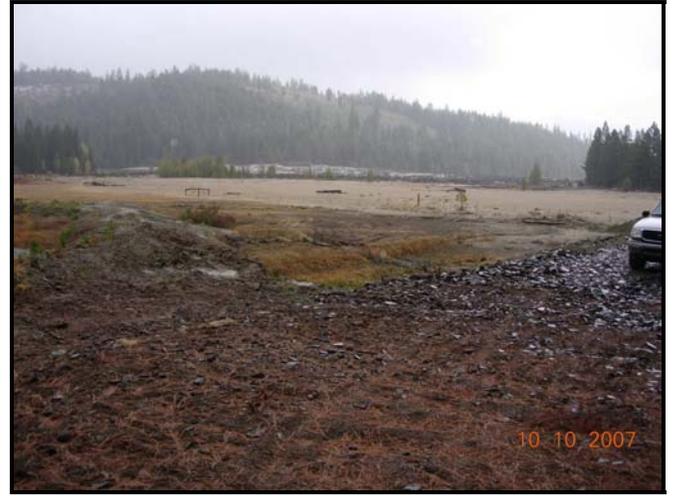
#14. Walker Mine tailings impoundment near the USFS dam.
