CENTRAL VALLEY REGIONAL WATER QUALITY CONTROL BOARD

INSPECTION REPORT

DISCHARGER: Walker Mine

INSPECTION DATE: 21 October 2009

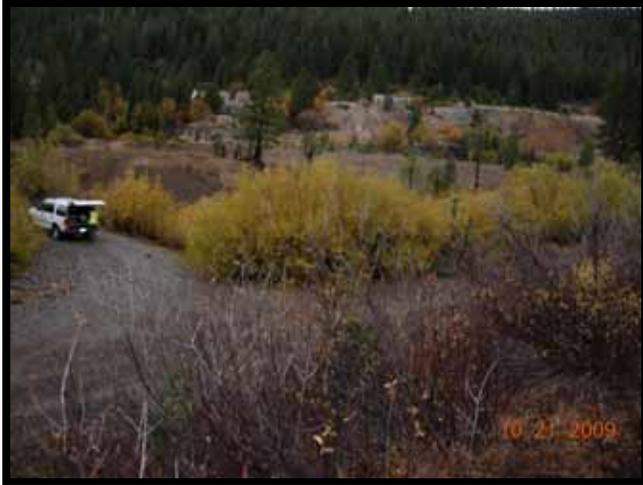
1. Walker Mine Portal Area.

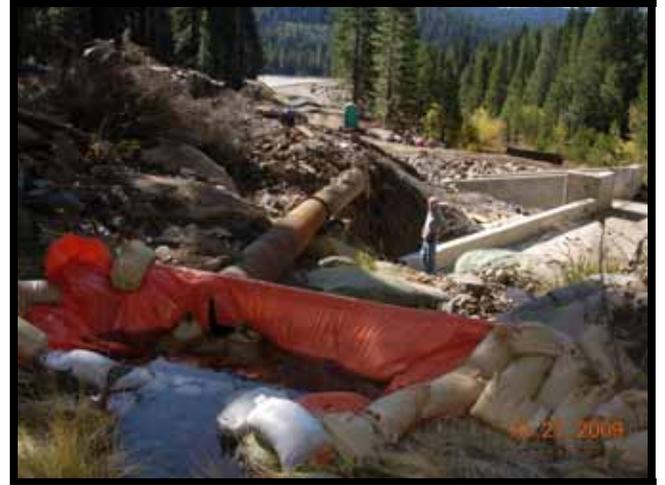
Renovations to the diversion channel headworks were nearly complete as shown in Photos #4-12. The prior design had not worked effectively, which resulted in a significant amount of subsurface drainage from Dolly Creek passing beneath the diversion structure and making its way to the old Dolly Creek channel.

4. USFS Headworks diversion above the Walker Mine tailings facility.

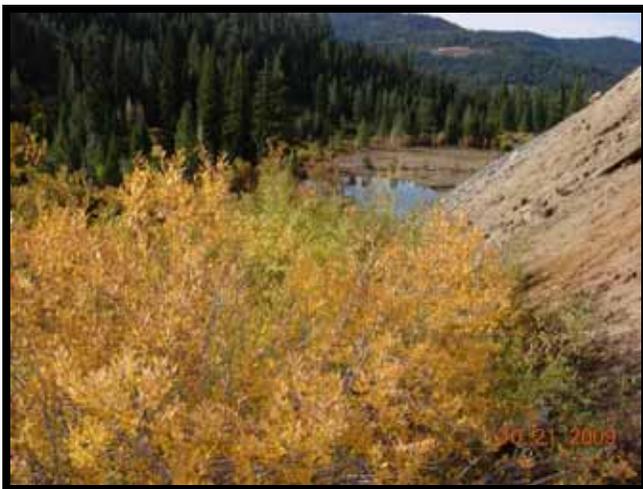
2. Looking west towards the tailings facility.

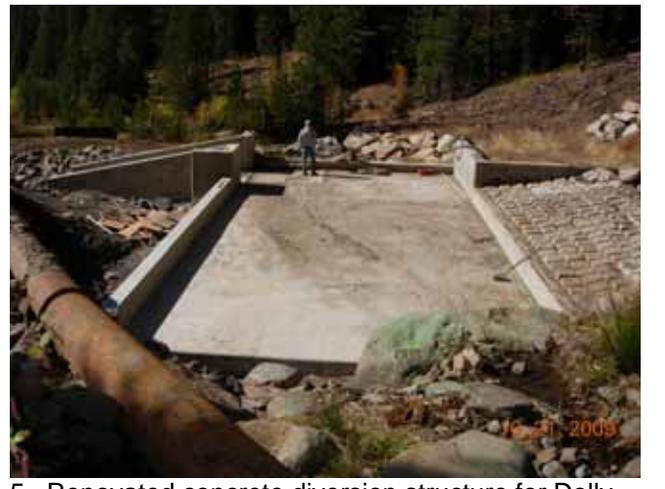
5. Renovated concrete diversion structure for Dolly Creek diversion.

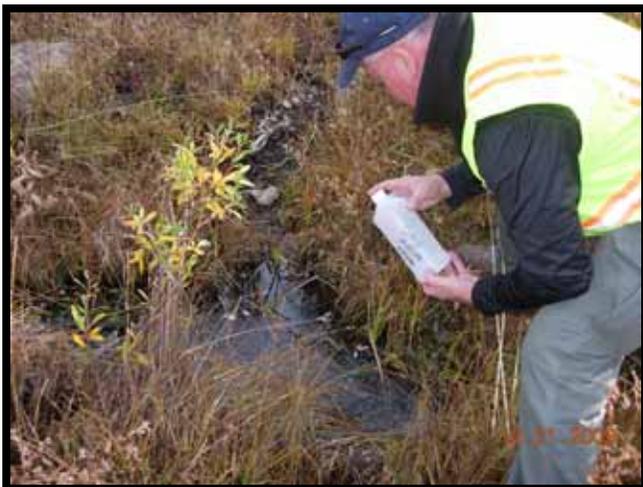
3. Sampling at Dolly Creek upstream (WM-2).

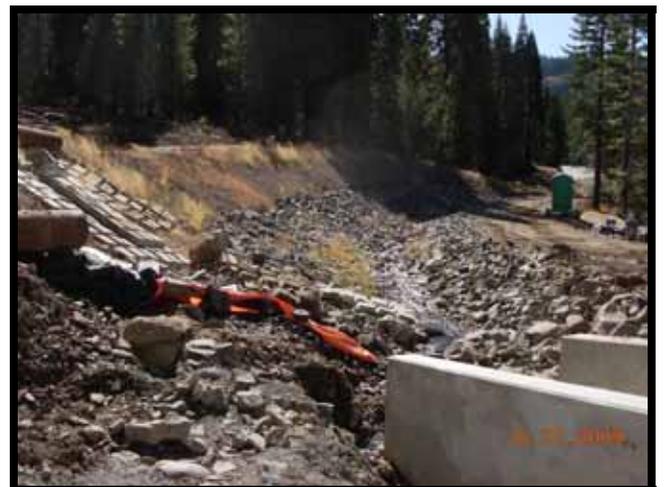
6. Outlet of Dolly Creek to the realignment across the Walker Mine tailings facility.

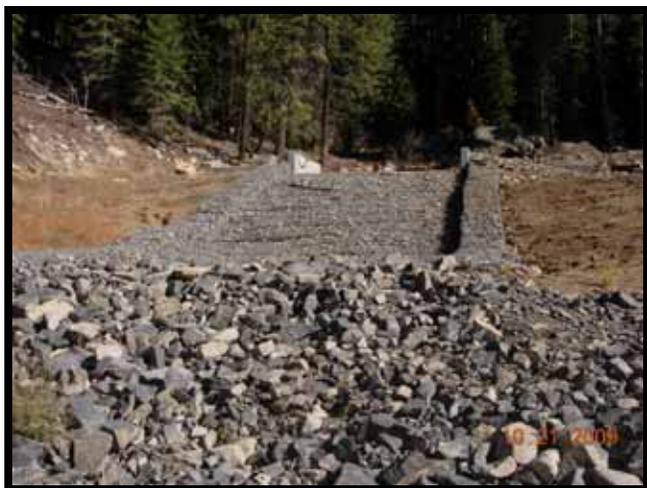
7. View of the 100 year storm emergency overflow to the old Dolly Creek channel.

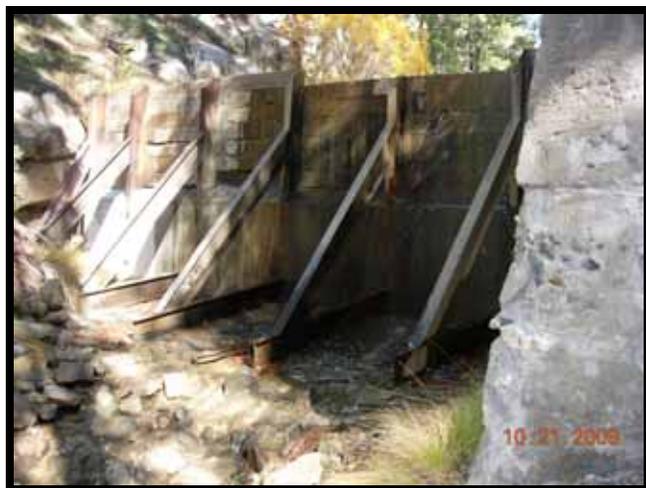
10. View of USFS dam with virtually no overflow. Most of the Dolly Creek water volume has been successfully diverted to the diversion channel.

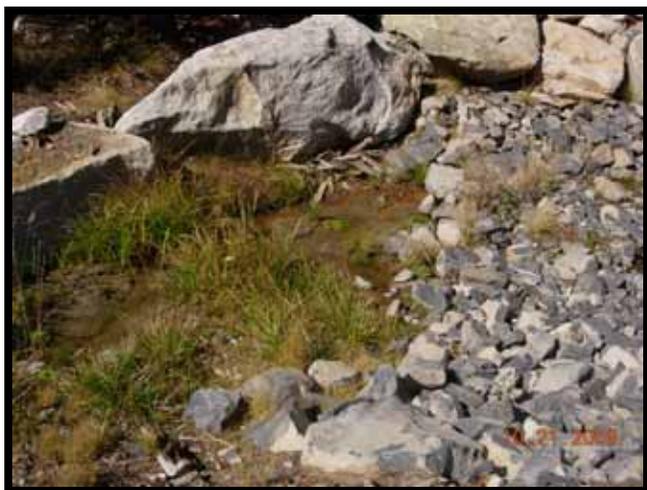
8. View of some minor subsurface underflow water seeping out at the base of the 100 year overflow.

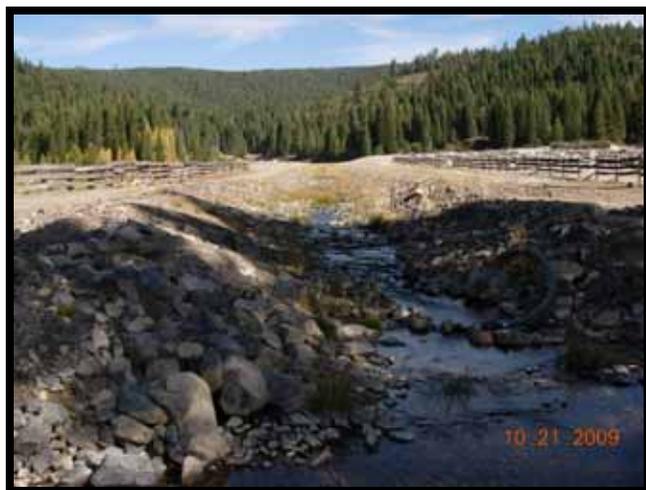
11. View of the Dolly Creek realignment across the Walker Mine tailings facility near junction with Little Grizzly Creek.

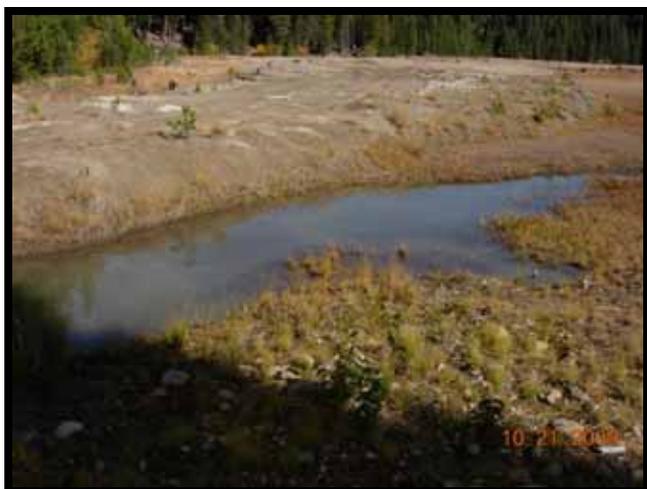
9. View of water remaining in the old Dolly Creek channel near the USFS dam.

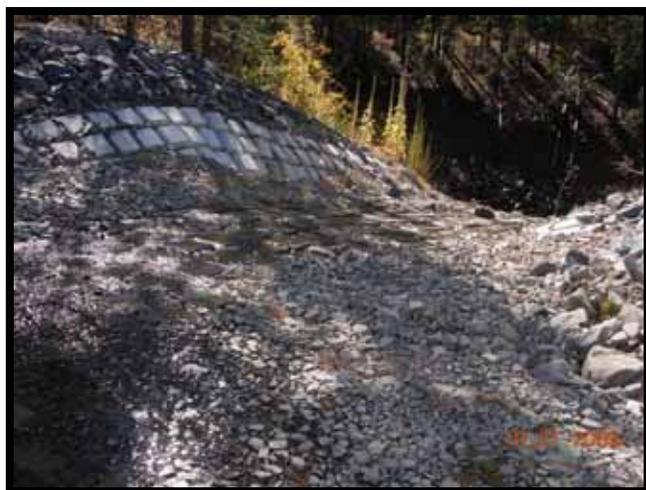
12. View of Dolly Creek realignment discharge structure to Little Grizzly Creek.
