CENTRAL VALLEY REGIONAL WATER QUALITY CONTROL BOARD

INSPECTION REPORT

DISCHARGER: Walker Mine, Abandoned and Unclaimed Private Property

INSPECTION DATE: 18-19 June 2013

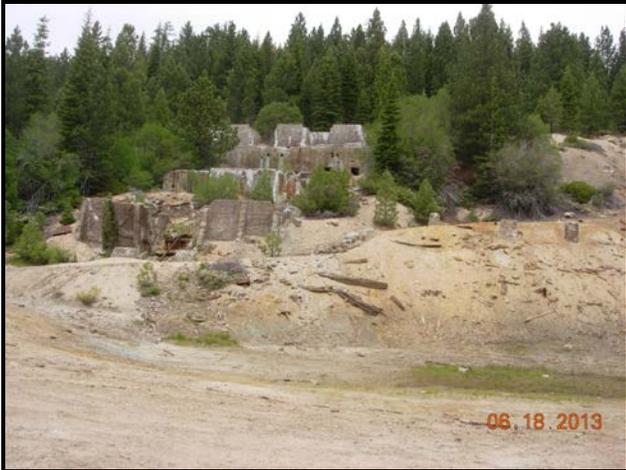
Photo 1. Walker Mine Concentrator and Mill Foundations.

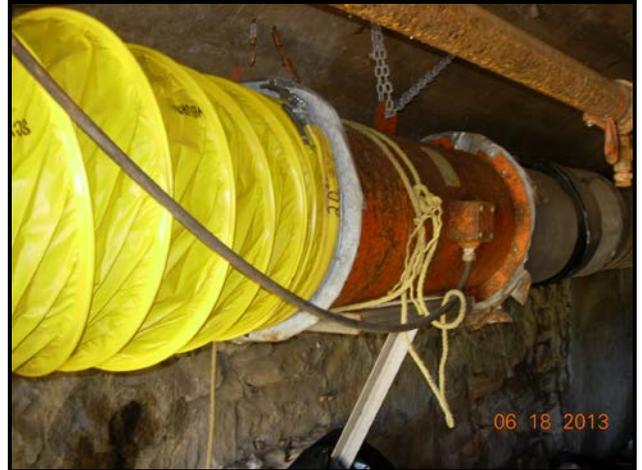
As shown in photos # 3-5, the flexible ventilation duct was hooked to the ventilation fan which was powered by the portable generator and fresh air was pushed through the rigid ventilation ducting to the mine seal. The ventilation system was allowed to run for approximately 1-hour before entry was made into the 700 level adit. This configuration results in fresh air continually being pushed towards the mine seal area in the 700 level adit and discernible airflow into the inspectors face as you advance into the 700 level adit.

Photo 4. Showing Jetair axiflow fan for ventilation of the 700 level adit.

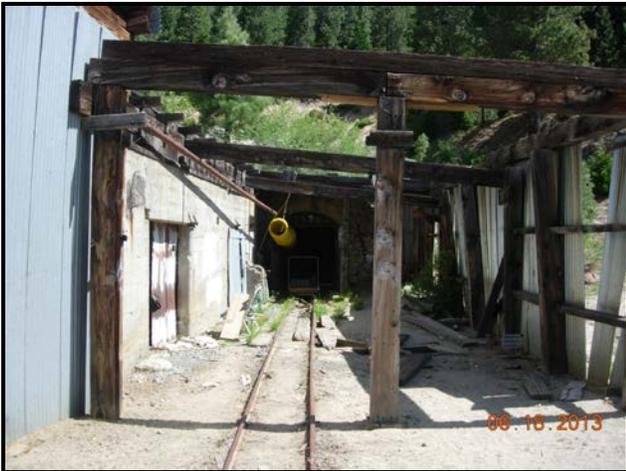
The portal door at the main 700 level adit was securely locked upon our arrival. There did not appear to be any new bullet holes in the steel door that secures access to the 700 level adit nor vandalism of the portal door. The drainage channel between the mine portal and the waste dump was open and flowing at about 0.5 gallons per minute. All four of the heavy-duty locks on the portal doors were securely locked upon leaving the mine portal.

Photo 2. Walker Mine 700 Level Adit/Portal.

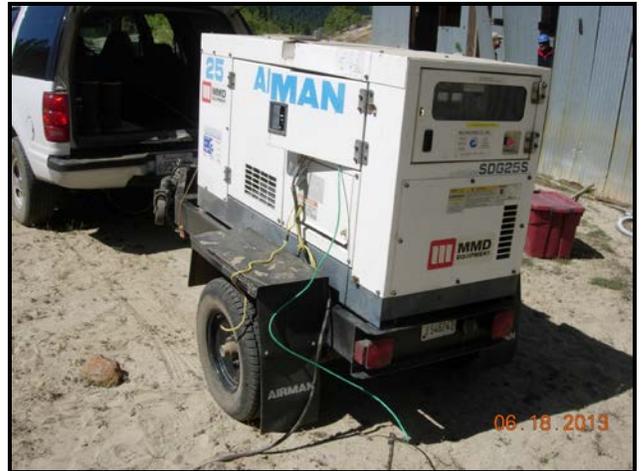
Photo 5. Portable generator used to power the ventilation fan.

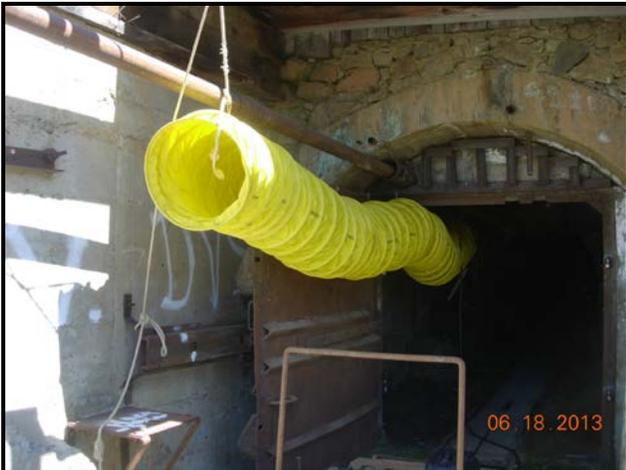
Photo 3. Flexible ventilation duct for the ventilation system at the Walker Mine.

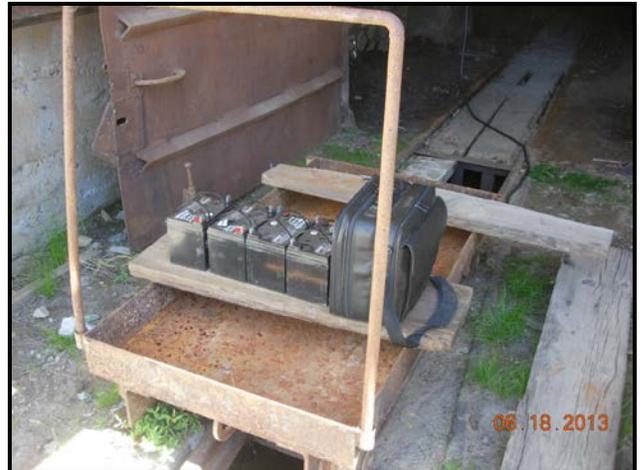
pressure head of 144.7 feet over the mine seal was recorded on 1 October 2012 indicating that 2012-2013 precipitation was below normal. Board staff downloaded the pressure data from the Telog data recorder during the inspection and used it to update the attached *Walker Mine Concrete Seal Pressure Head and Snow Water Content* graph which is attached to this report. The batteries that power the Druck pressure sensor recorder were removed and replaced with recharged batteries during this inspection (photo #6).

Photo 6. Fresh batteries for the Walker Mine pressure data recorder.

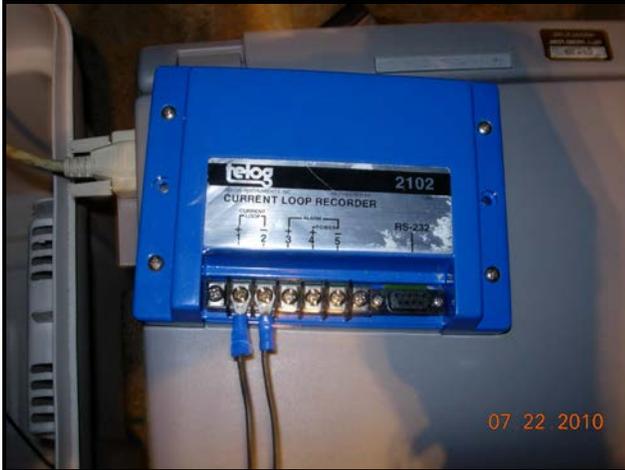
A brief inspection of the Telog pressure data recorder (photo #7) indicated that it was recording pressure data daily as programmed. The Telog data recorder is connected via a 2,500-foot long electronic cable to a Druck pressure sensor at the mine seal. Once per day the data recorder measures and stores an electronic current measurement (mAmps) from the Druck pressure sensor. This data is converted mathematically by Board staff to feet of pressure head on the mine seal¹. At the time of the inspection, a current measurement of 7.06 mAmps (approximately 141 feet of head over the mine seal) was recorded. For the period 1 October 2012 through 16 June 2013, a maximum

Photo 7. Prior photo of the Walker Mine pressure data recorder located approximately 200 feet inside the 700 level adit.

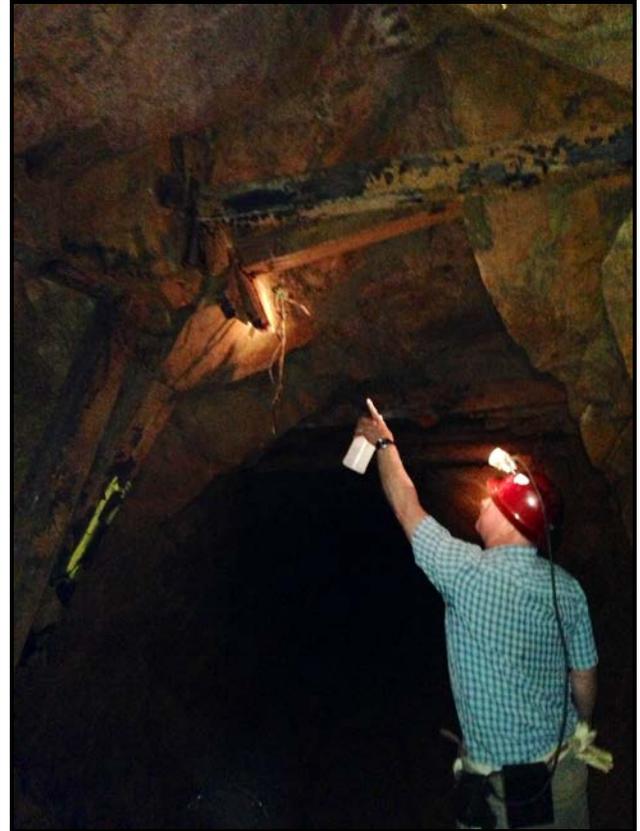
As shown in photo #9, no scaling was necessary in the unsupported section of the 700 level and no signs of recent rockfall were noted. Water seepage observed in the unsupported section was minimal.

Photo 9. Examining a stull in the unsupported section of the 700 level adit. No scaling was necessary and no signs of recent rockfall were noted. Water seepage observed in the unsupported section was minimal.

An experience underground mine contractor should be hired to inspect the timbered section and the unsupported section of the 700 level adit for signs of ground support deterioration. Furthermore, while the stainless steel piping and valves need to be inspected and physically tested to ensure their operability in accordance with the Board's Operations and Maintenance Plan for the Walker Mine, there is some potential risk that the valves cannot be completely closed after being opened.

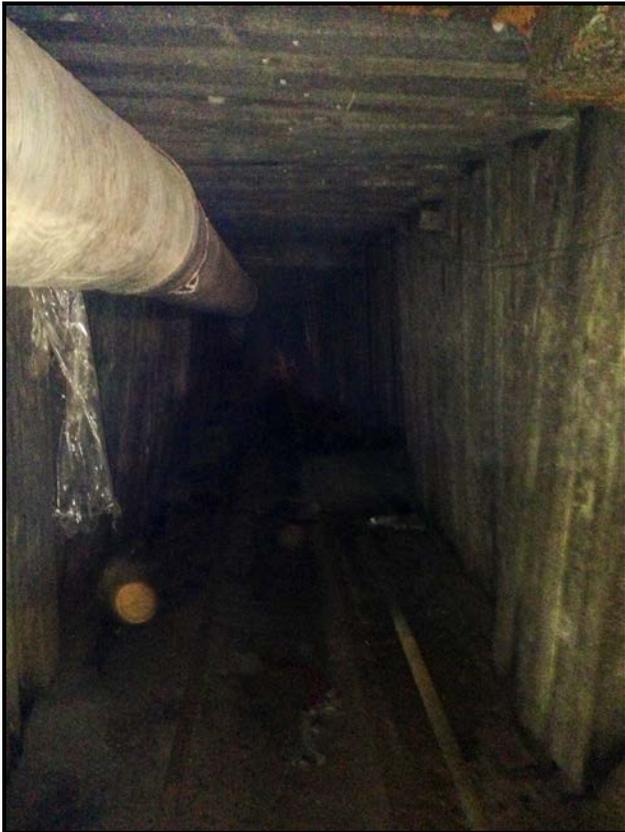
As shown in photo #8, the timbered section of the 700 level was open and clear. Conditions in this section were wet and appear to be from shallow groundwater infiltration from the hillside directly above the timber supported section (first 900 feet) of the 700 level adit. No major support problems were observed. However, a number of the timber sets, lagging, and blocking are showing signs of significant decay and need to be replaced.

Photo 8. Timber supported section of the 700 level adit. No major support problems were observed, however a number of the timber sets, lagging, and blocking are showing signs of significant decay and should be replaced.

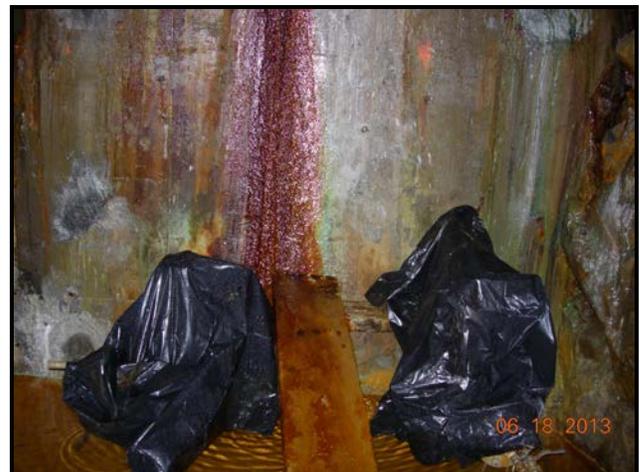
Conditions at the mine seal are shown in photos #10-14. Water seepage from around the mine seal and pooled water conditions at the base of the mine seal appeared to be unchanged since July of 2010. Seepage appears to come from the crown of the seal and along both sides. Iron precipitate is evident on the face of the mine seal (nearly centered) but does not appear to be significantly different than that shown in the *Walker Mine Seal Testing and Evaluation Report* (GEI Consultants, 1 March 2002). The piping and valves were uncovered and inspected and no seepage or significant changes in corrosion were noted. The valves have not been tested for a number of years due to concern that they may not close completely if opened. Samples of the water pooled at the base of the seal (monitoring location #30) were collected for laboratory analysis.

Photo 10. Taken at the concrete mine seal in the 700 level adit. Plastic bags are used to protect the twin stainless steel valves, pressure transmitter, and pressure gauge.

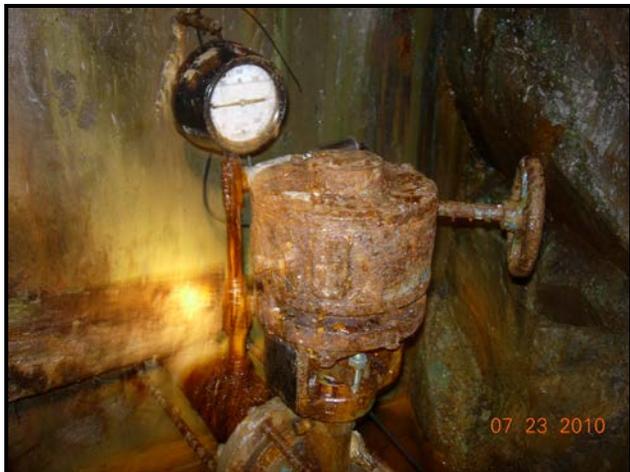
Photo 11. Prior photo of the 4-inch valve and pressure gauge at the mine seal.

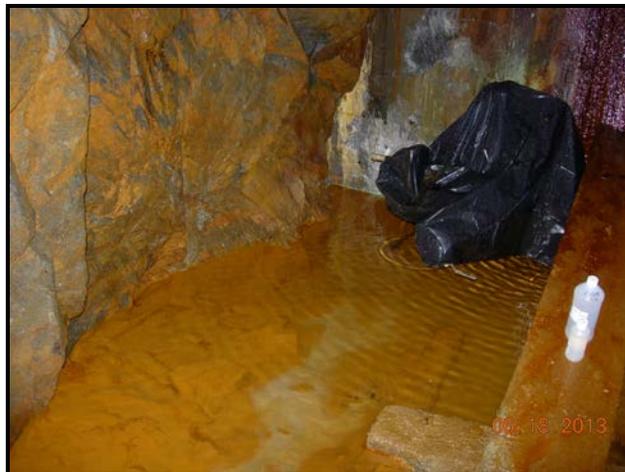
Photo 14. Pooled water is approximately 14 inches deep at the base of the mine seal. No significant changes were noted at the mine seal location.

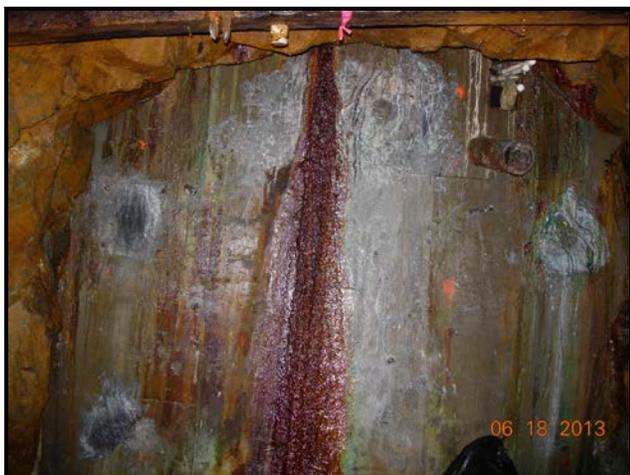
Photo 12. Showing iron precipitate forming on the face of the mine seal from seepage around the seal.

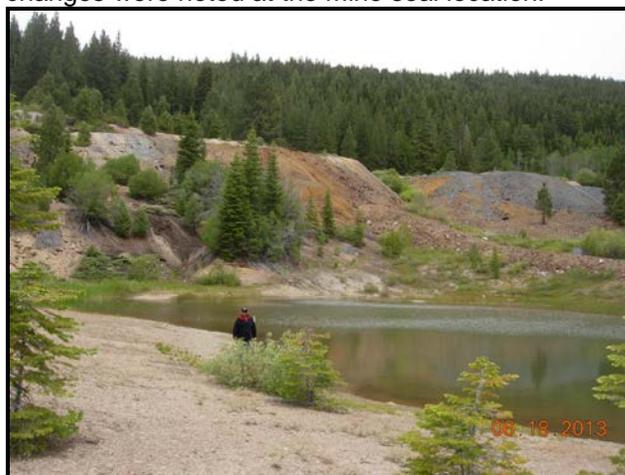
Photo 15. Settling pond located below the Walker Mine portal.

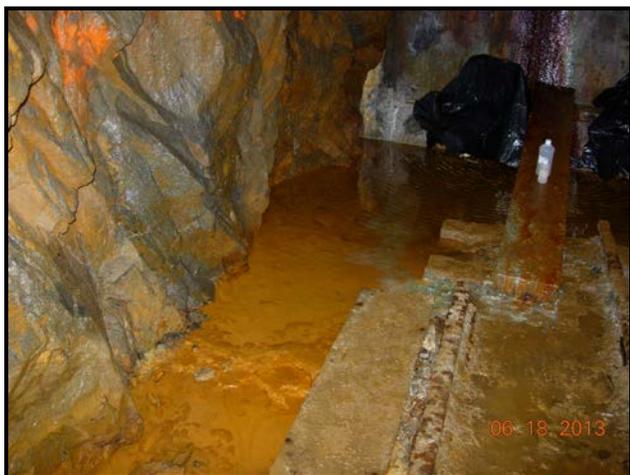
Photo 13. Showing the extent of standing water from seepage around the mine seal. The water seeps into the floor of the 700 level adit within 200 feet of the seal.

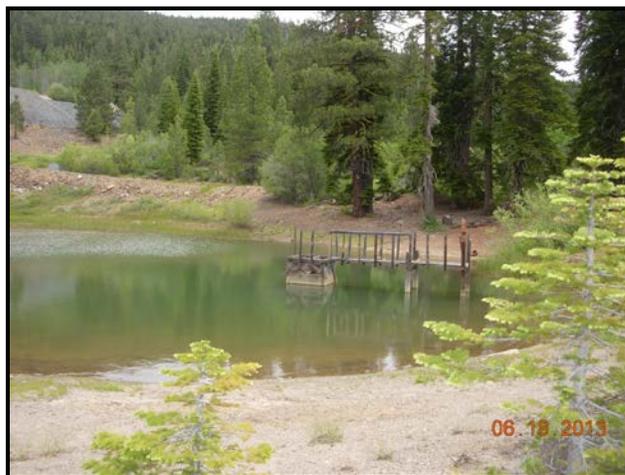
Photo 16. Photo of the west side of the settling pond, monitoring location #19.

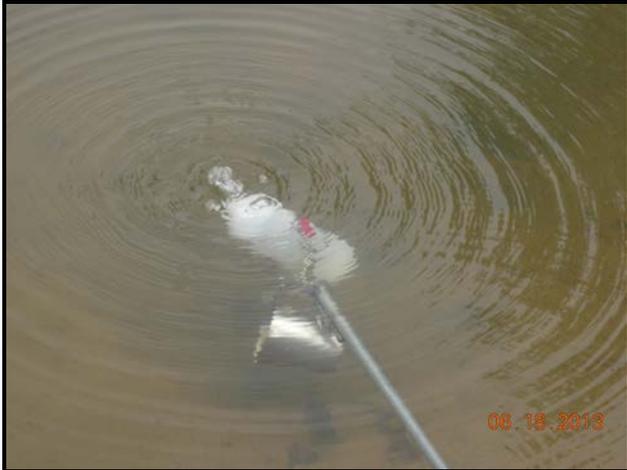
Photo 17. Sampling at monitoring location #19.

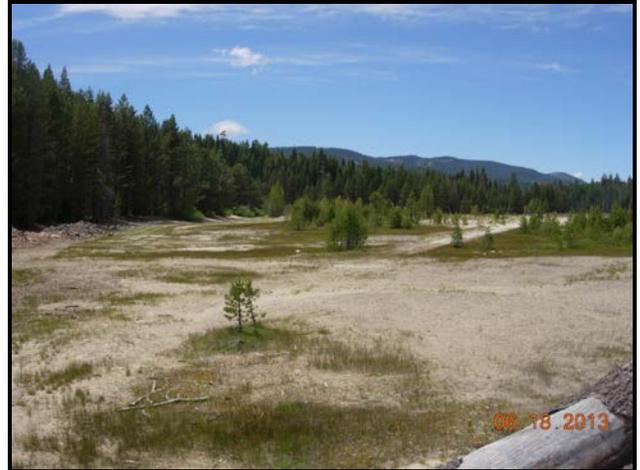
Photo 20. Taken from southeast side of the Walker Mine tailings impoundment looking northwest.

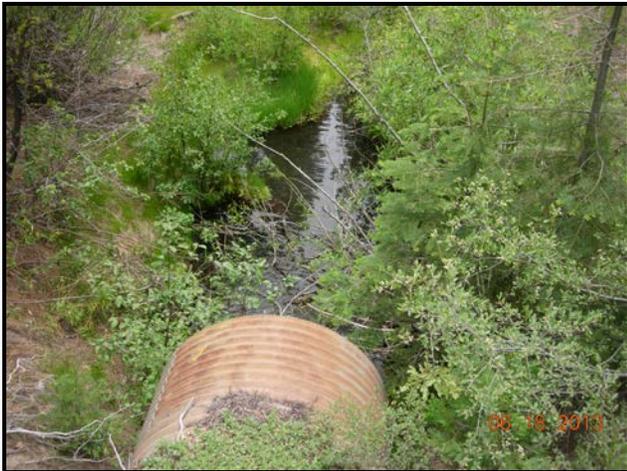
Photo 18. Photo of monitoring location #4, Dolly Creek crossing County Road 112 below the Walker Mine.

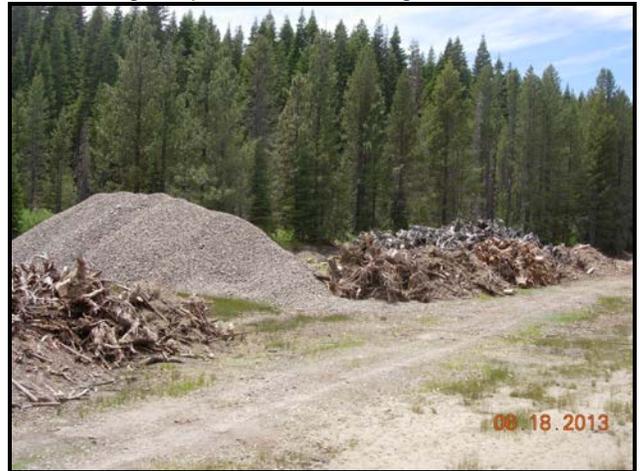
Photo 21. Southeast side of the Walker Mine tailings impoundment showing stockpiled stumps and gravel from the USFS 2008 construction of the Dolly Creek diversion channel.

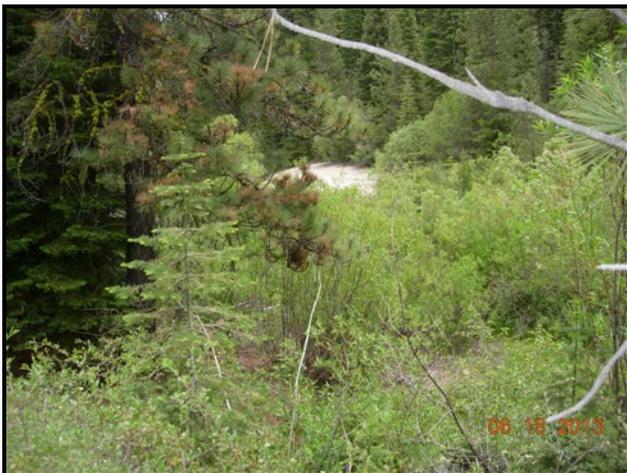
Photo 19. Taken from spot of previous photo showing exposed tailings in the Dolly Creek drainage below County Road 112.

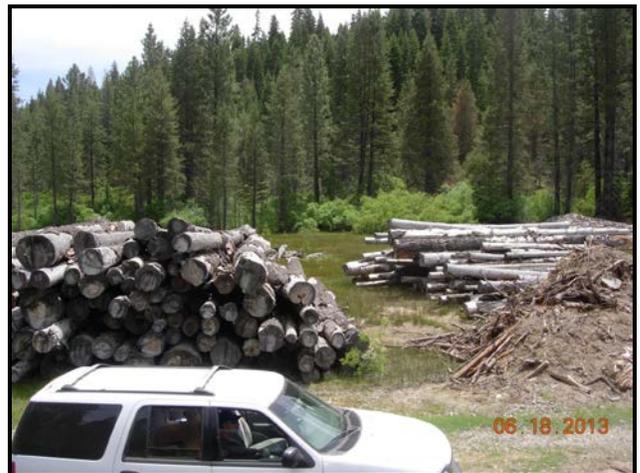
Photo 22. Taken from same location as photos 20-21 showing stockpiled logs and debris at the Walker Mine tailings impoundment.

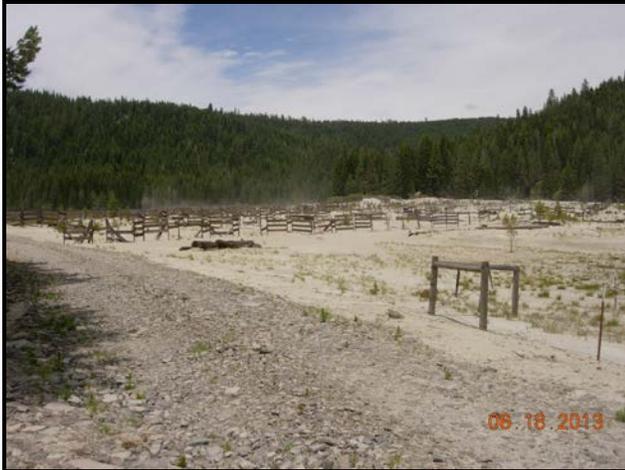
Photo 23. Showing wind erosion control structures (wind fences) on southeastern side of the tailings.

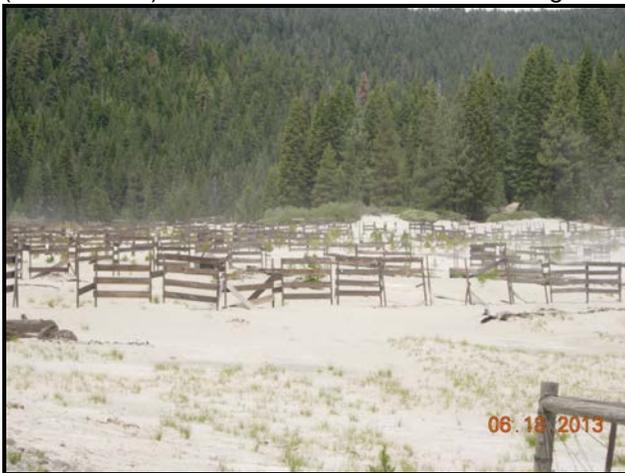
Photo 24. Showing fugitive dust (tailings). Wind conditions were considered to be slight.

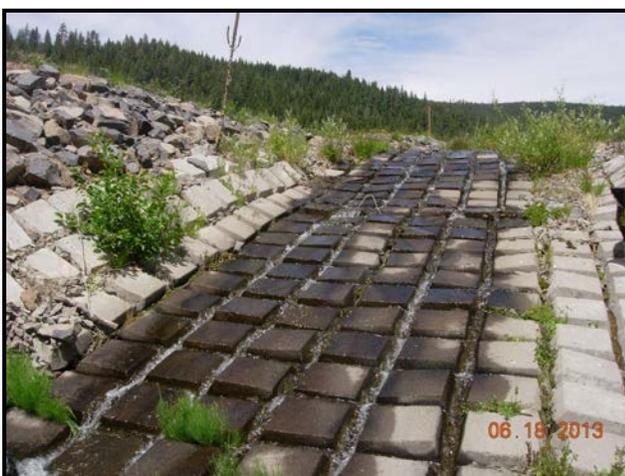
Photo 25. Showing the Dolly Creek diversion channel outfall to Little Grizzly Creek. Photo taken from Little Grizzly Creek.

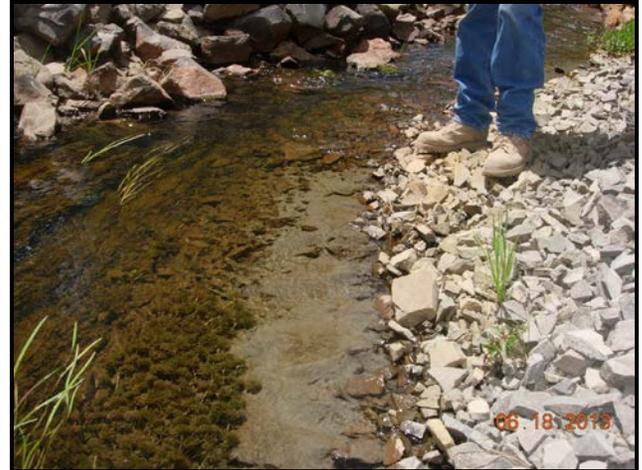
Photo 26. Photo of Dolly Creek outfall to Little Grizzly Creek showing fine grained sediment (tailings) being discharged to Little Grizzly Creek.

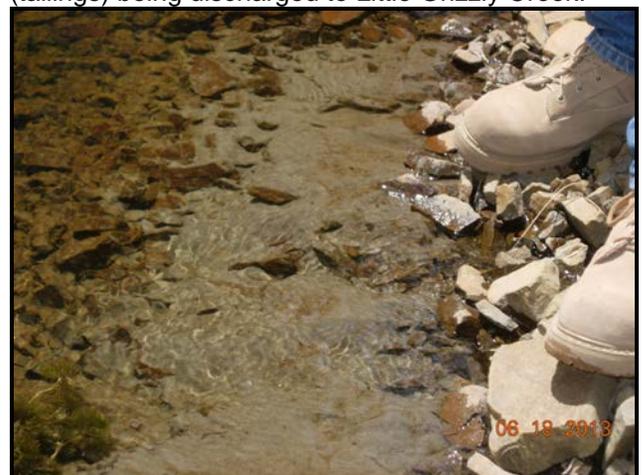
Photo 27. Closeup view of Photo 26.

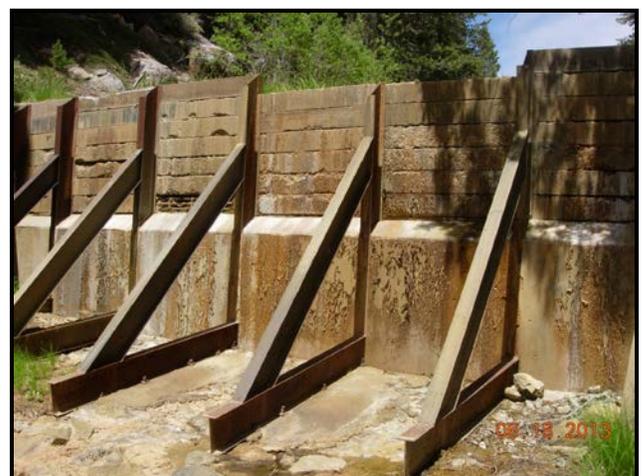
Photo 28. USFS Dam, monitoring location #6. No water was observed flowing over the dam.

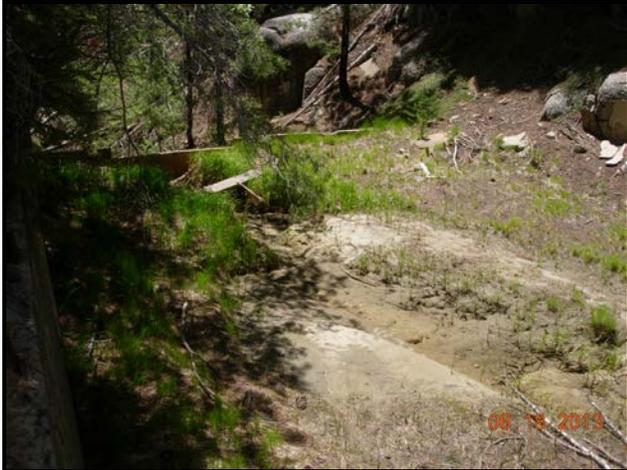
Photo 29. Taken from the upstream side of the USFS Dam. No water was observed at this location.

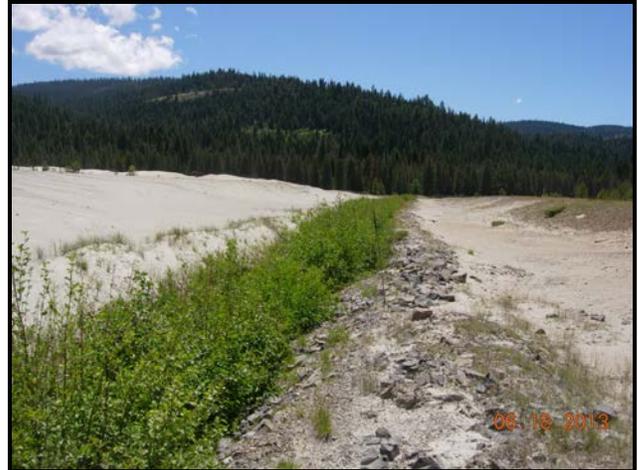
Photo 32. Showing well established vegetation in the Dolly Creek diversion channel.

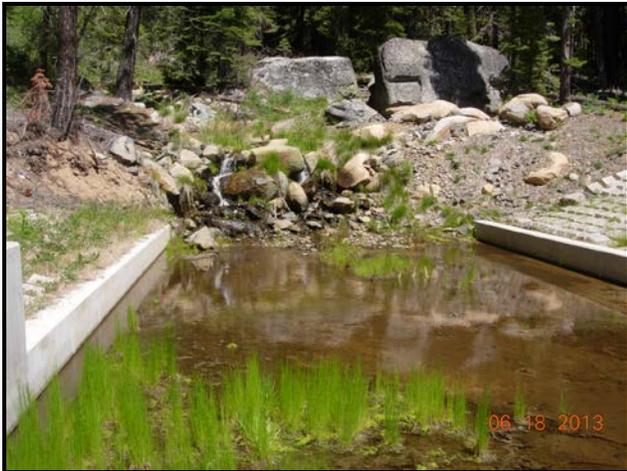
Photo 30. Showing the Dolly Creek diversion channel headwork's above the tailings impoundment.

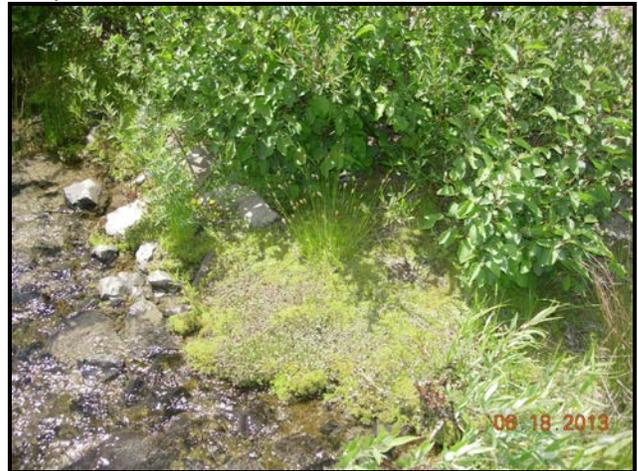
Photo 33. Showing the base of the vegetation in the Dolly Creek diversion channel.

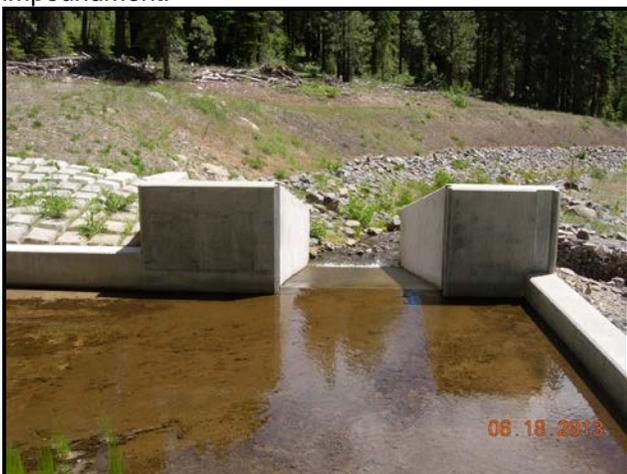
Photo 31. Showing the headwork's outfall to the Dolly Creek diversion channel realignment.

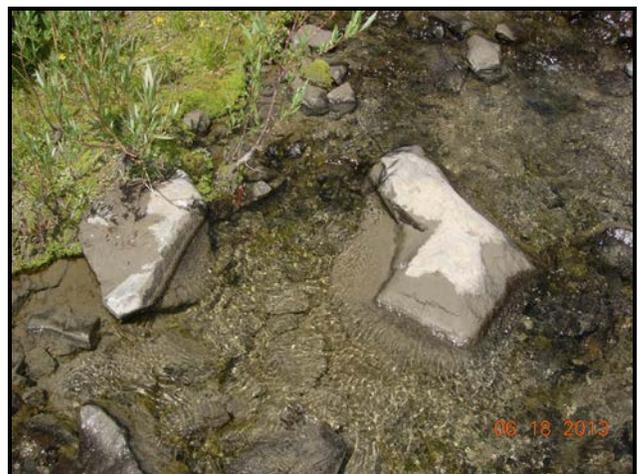
Photo 34. Showing fine grained sediment (tailings) in the Dolly Creek diversion channel.
