California Regional Water Quality Control Board, San Diego Region

Subject: Notice of Violation No. R9-2015-0056 and Water Code Section 13267 Request for Technical Report, City of Carlsbad

**NOTICE OF VIOLATION
No. R9-2015-0056**

Facility: Robertson Ranch
Inspection Date: 12/12/2014

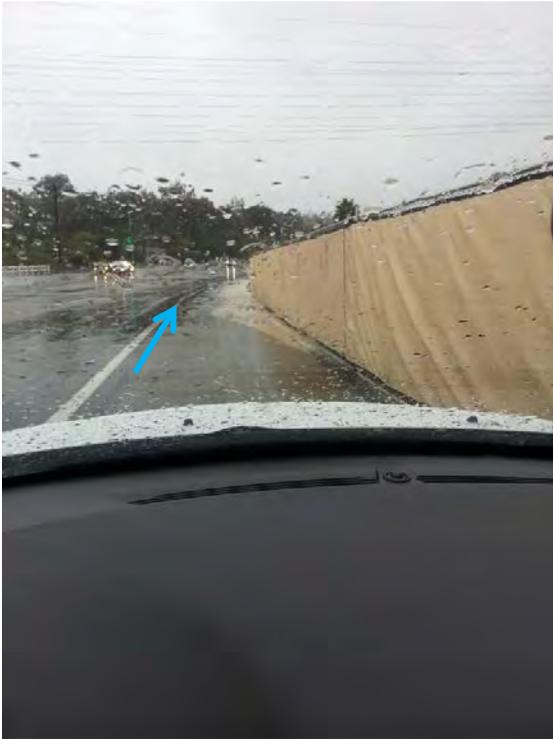
Photo 1: Mobilized sediment leaving Robertson Ranch construction site along the NW perimeter (view northwest on El Camino Real).

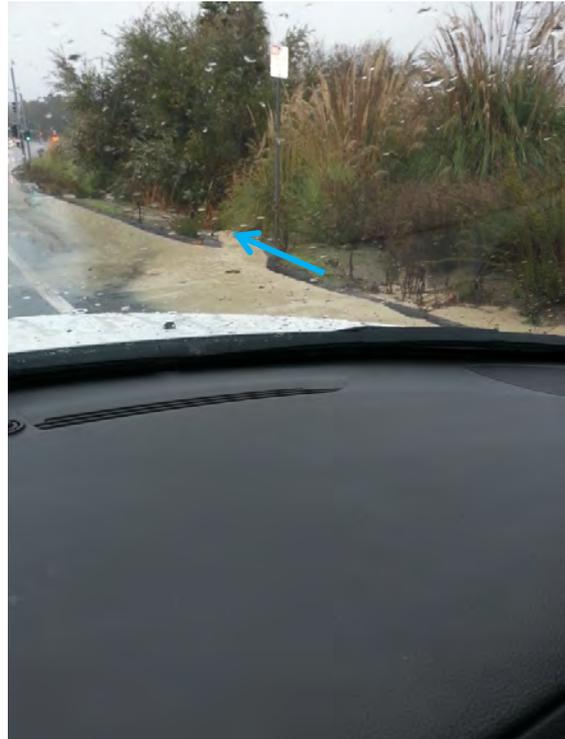
Photo 2: Mobilized sediment downstream of Photo 1 draining into tributary drainage (view NW on El Camino Real).

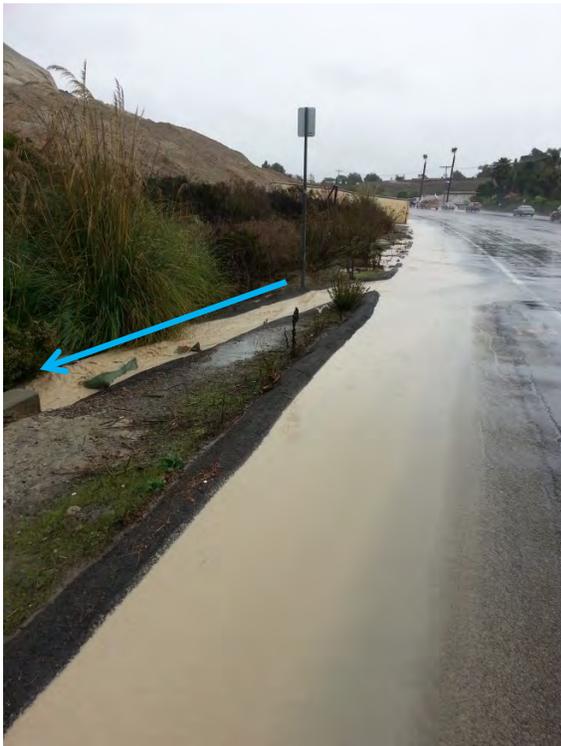
Photo 3: Mobilized sediment discharging into tributary drainage displayed in photo 2 (looking south along El Camino Real).

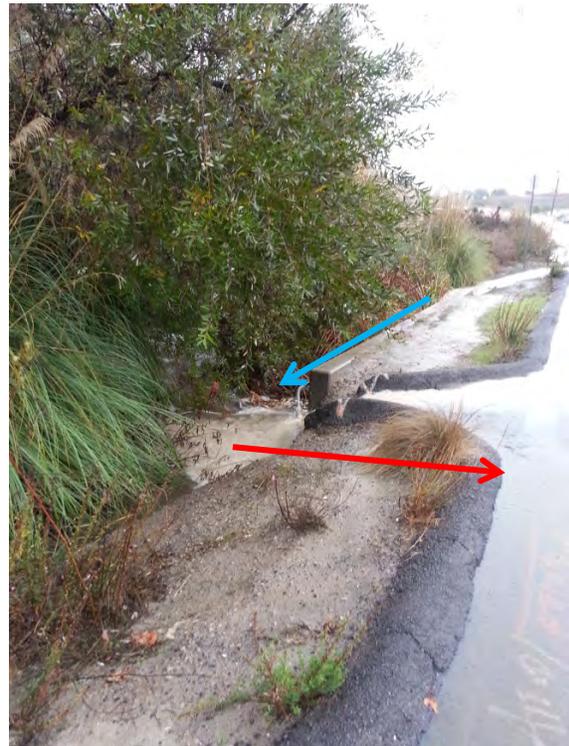
Photo 4: Mobilized sediment discharging into drainage culvert underneath El Camino Real (red).

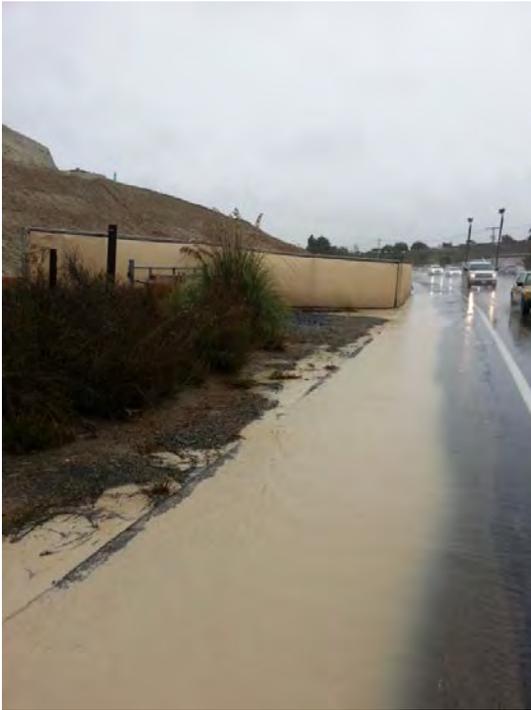
Photo 5: Discharge looking south along El Camino Real. Large slopes on site without erosion control shown in photo.

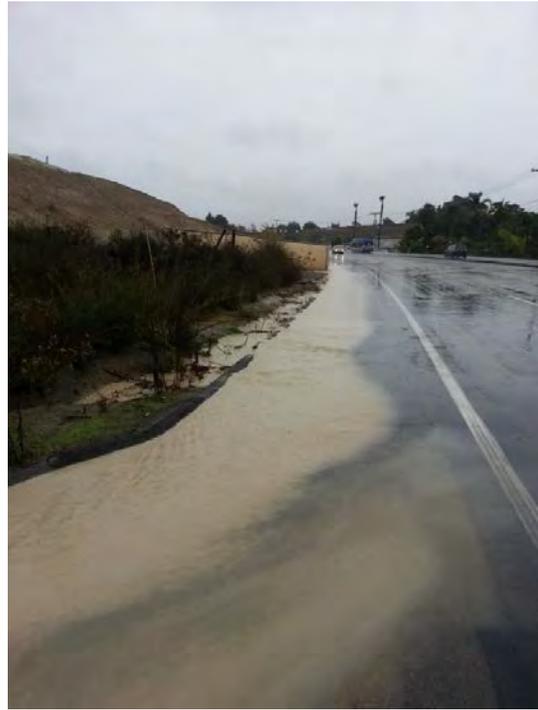
Photo 6: Discharge looking south along El Camino Real. Large slopes on site without erosion control shown in photo.

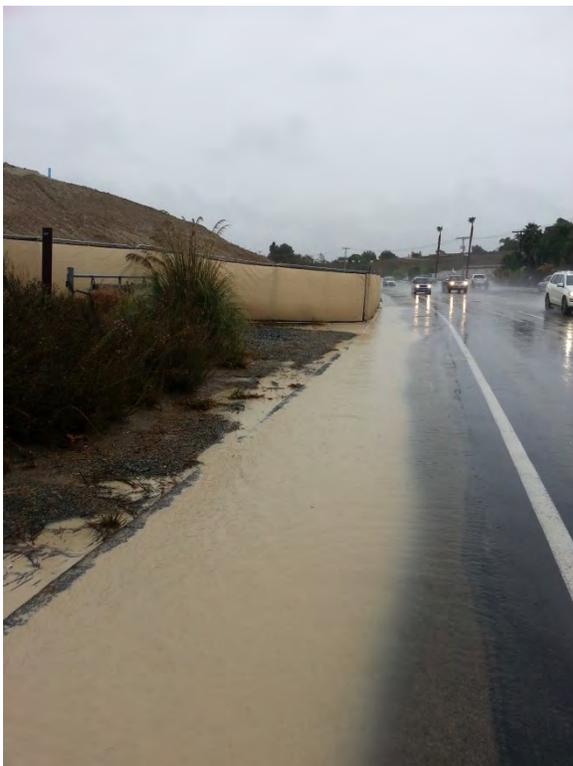
Photo 7 Discharge looking south along El Camino Real. Large slopes on site without erosion control shown in photo.

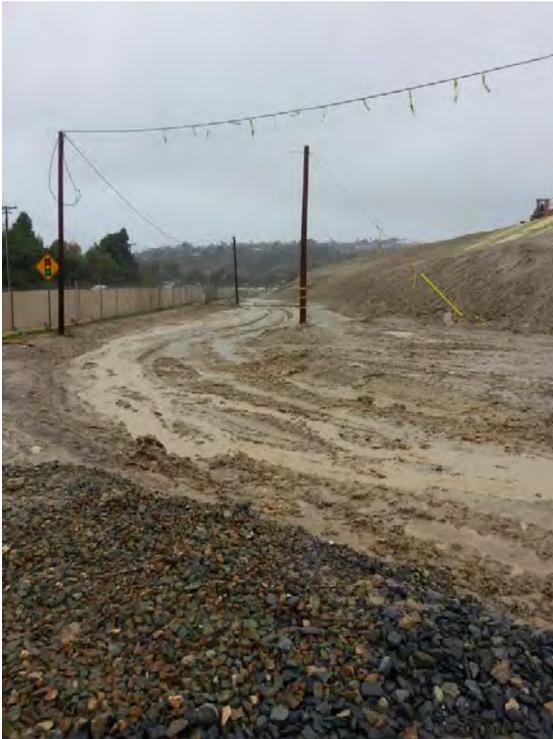
Photo 9 No erosion controls present on large slopes. No linear sediment controls on large slopes. No erosion in conjunction with sediment controls present on other areas of site.

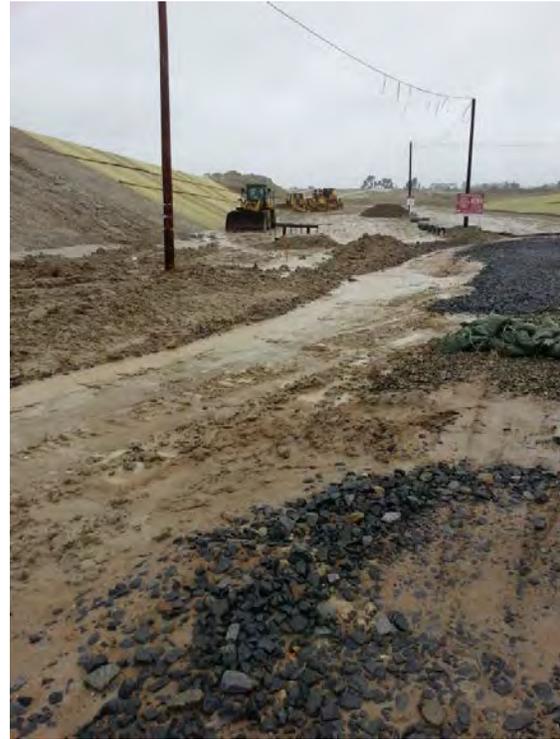
Photo 10 Partial erosion control present (i.e. straw blankets) on one large slope. Partial linear sediment controls on a part of the large slope in this photo. No erosion in conjunction with sediment controls present on other areas of site in this photo.

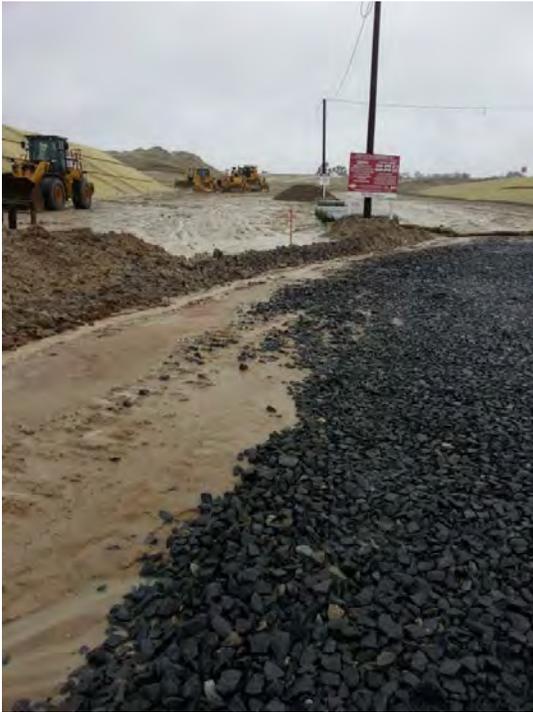
Photo 11 Partial erosion control present (i.e. straw blankets) on one large slope. Partial linear sediment controls on a part of the large slope in this photo. No erosion in conjunction with sediment controls present on other areas of site in this photo.

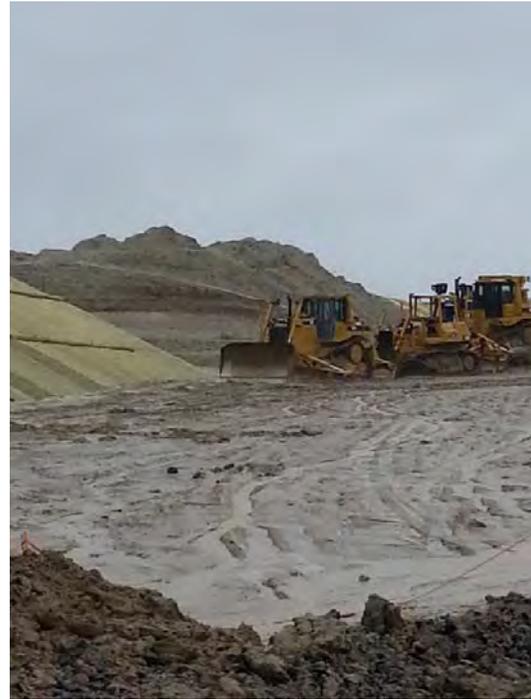
Photo 12 Partial erosion control present (i.e. straw blankets) on one large slope. Partial linear sediment controls on a part of the large slope in this photo. No erosion in conjunction with sediment controls present on other areas of site in this photo. No protection on large open areas of excavated land shown in back of photo.

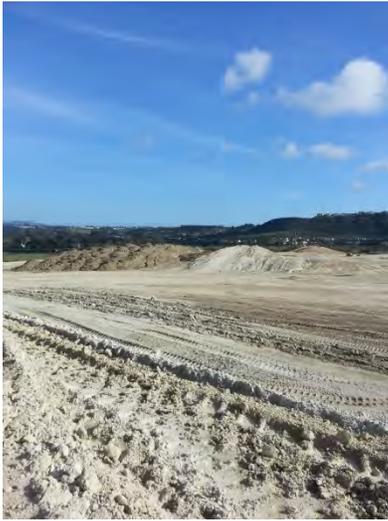
Photo 1: Loose soil stockpiles were not covered or bermed. Evidence supports stockpiles were not being used because there is no disturbance of pile.

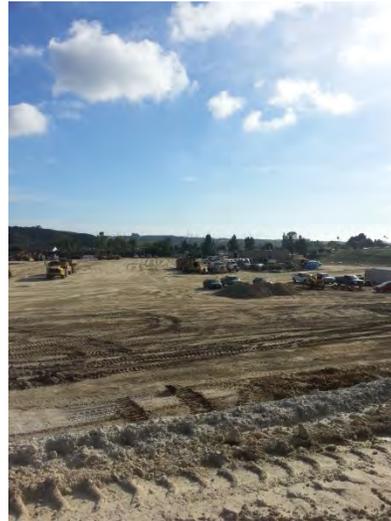
Photo 2: Loose piles of gravel were not covered or bermed. Evidence supports stockpiles were not being used because there is no disturbance of pile.

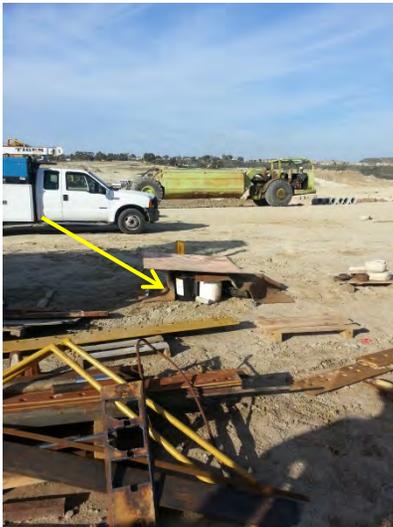
Photo 3: Chemicals were not stored in watertight container or storage shed. Waste without secondary containment and not protected from wind and rain.

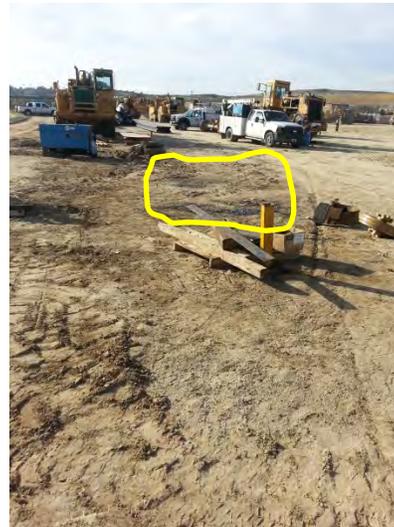
Photo 4: Leaks to the ground must be cleaned up immediately and disposed of leaked materials appropriately.

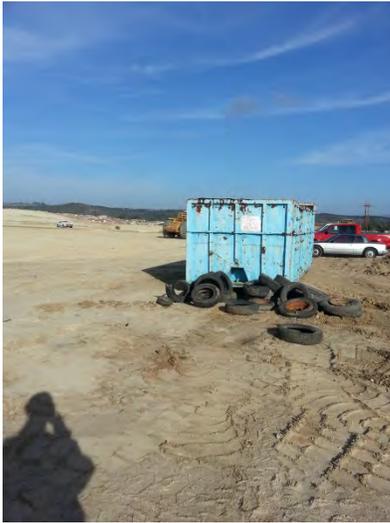
Photo 5: Stockpiled tires not contained and securely protected from rain. Waste bin not covered and no evidence of cover nearby indicating that the container is covered at the end of each workday.

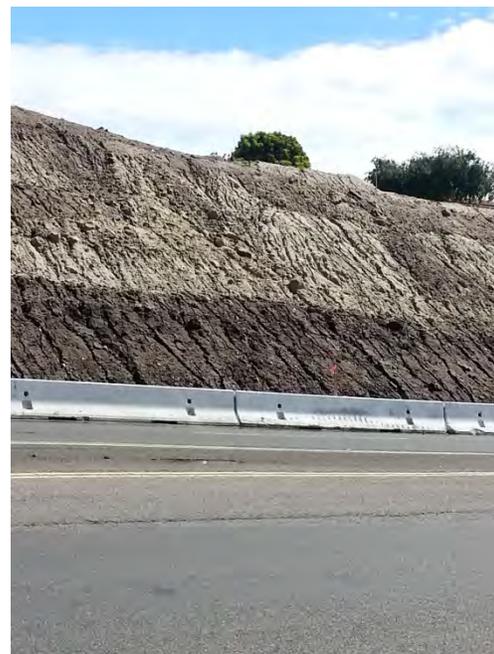
Photo 4: Evidence of significant erosion on steep slopes as the result of slopes being unprotected from erosion, of soil stabilizer(s) not being used, and failure to install linear sediment controls. (view is east along El Camino Real at the north end of the site at 1130 hours).

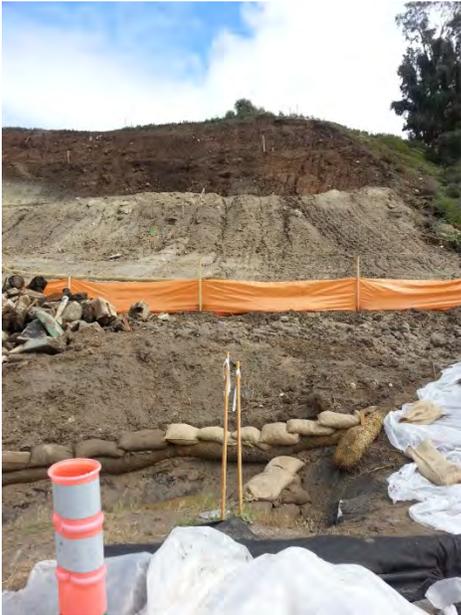
Photo 5: Project site slopes unprotected from erosion. Soil stabilizer(s) not in place. Linear sediment controls not in place. Silt fence and gravel bag berms installed after rain event (See Attachment No. 1 - 3-02-15 City of Carlsbad Incident Summary Photo at 0745 and 0930 – silt fence not installed) (view is east perpendicular to El Camino Real at the south end of the site at 1130 hours).

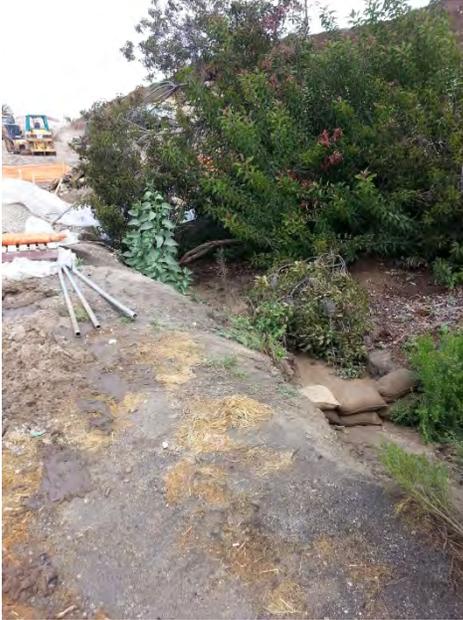
Photo 9 Lack of perimeter controls, inadequate run-on controls, lack of erosion in conjunction with sedimentation controls, and lack of soil stabilization controls resulted in a discharge of sediment and sediment laden water from the site. Discharge of sediment beyond the gravel bag dike and sediment deposited as seen in Photo 10 is evidence that sediment was discharged from the site to the unnamed tributary to Agua Hedionda Creek and Agua Hedionda Lagoon. (view is at south end of the site at the discharge point looking north).

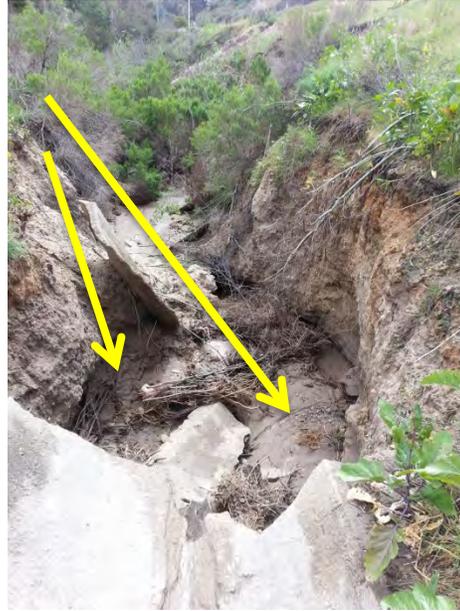
Photo 10 Discharge of sediment traveled along concrete v-ditch shown in Photo 9 to discharge to earthen bottom unnamed tributary as seen here to Agua Hedionda Creek and Agua Hedionda Lagoon. Photo Evidence shows discharge from the site caused or contributed to hydromodification in this receiving water. This project is also required to comply with San Diego Water Board Water Quality Certification 08C-074. (view south of the site, in the unnamed tributary to Agua Hedionda Creek and Agua Hedionda Lagoon at the point where the concrete v-ditch discharges into the earth bottom receiving water).

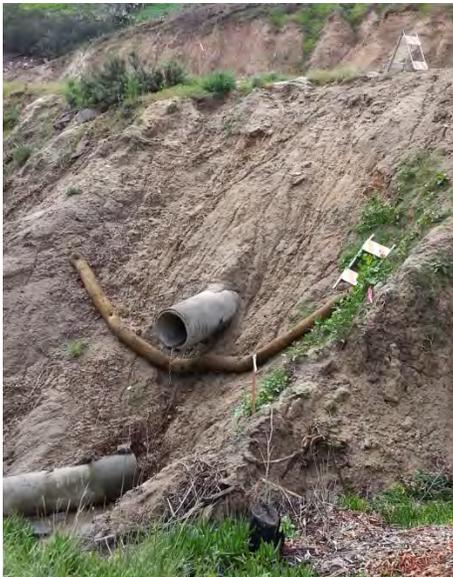
Photo 11 Lack of perimeter controls, inadequate run-on controls, lack of erosion in conjunction with sedimentation controls. (view is south of Photo 10 in the unnamed tributary to Agua Hedionda Creek and Agua Hedionda Lagoon).

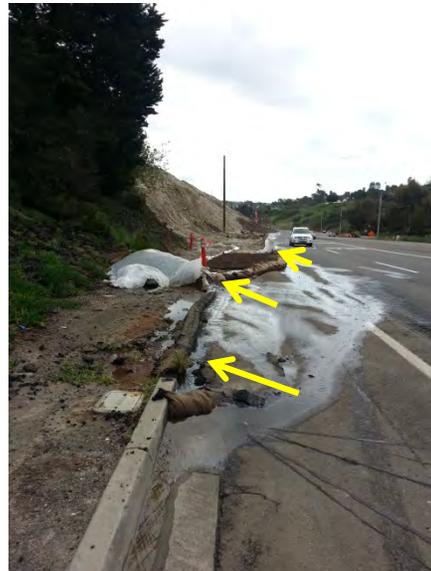
Photo 12 Ineffective perimeter controls and protection from run-on. Storm water run-on flow pattern seen here. Breached perimeter and run-on controls shown by yellow line. Perimeter controls and run-on protection was reinforced after the rain event (See Attachment No. 1 - 3-02-15 City of Carlsbad Incident Summary Photo at 0745 and 0930)

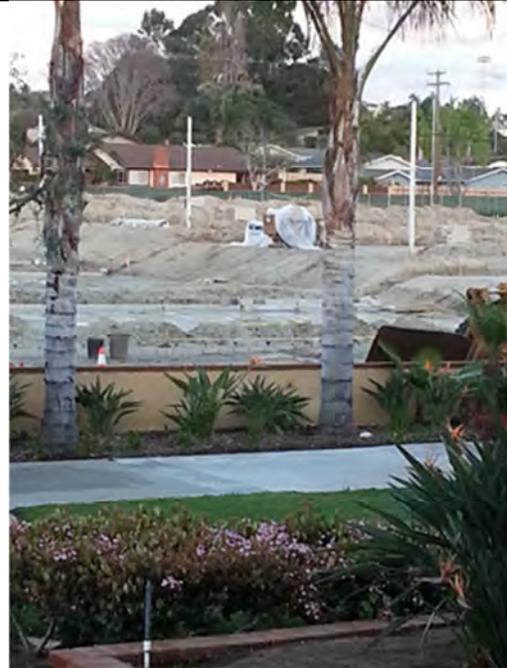
Photo 2 - Construction with without erosion control present on interior slopes. Site discharges to Buena Vista Lagoon a 303d listed water body impaired for sedimentation.

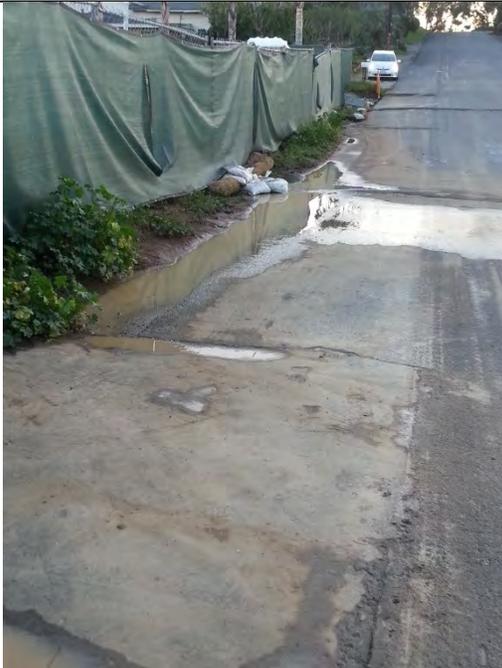
Photo 5 - Evidence of sediment discharged from the site. Street stained by sediment discharge and sediment laden water present on street. Fiber rolls are improperly installed.

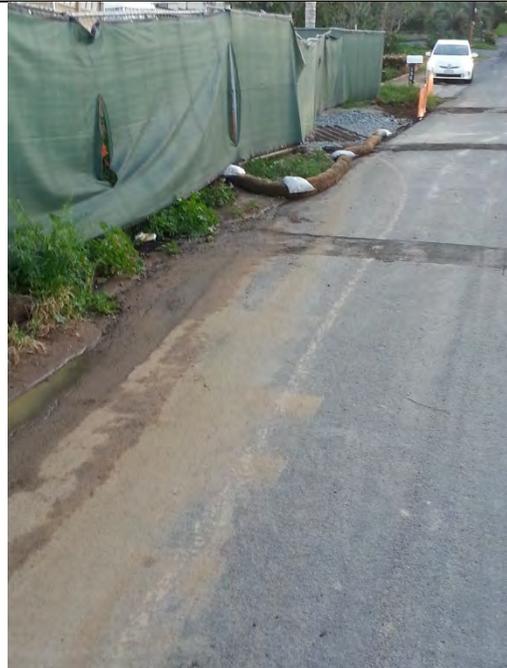
Photo 6 – Evidence of sediment discharged from the site. Fiber rolls are improperly installed. Proper installation involves trenching in rolls and staking them in.

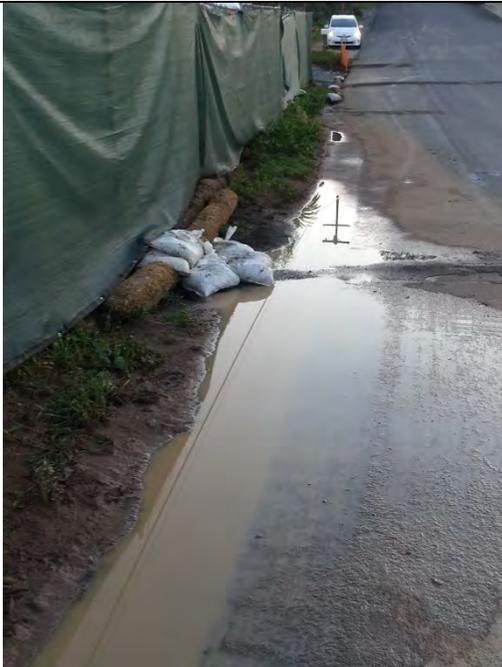
Photo 7 – Evidence of sediment and sediment laden water discharged from the site to the MS4. Staining of sediment is visible in the photo.

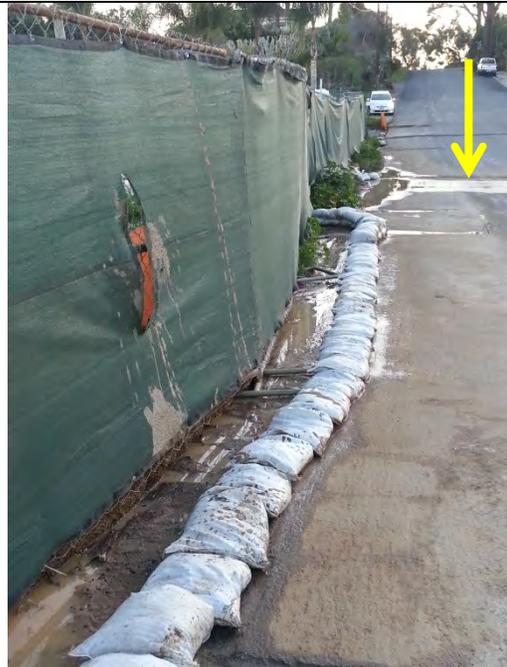
Photo 8 – Evidence of the discharge pathway from the site to the MS4 inlet across the street. Evidence of sediment staining along Oak Ave.

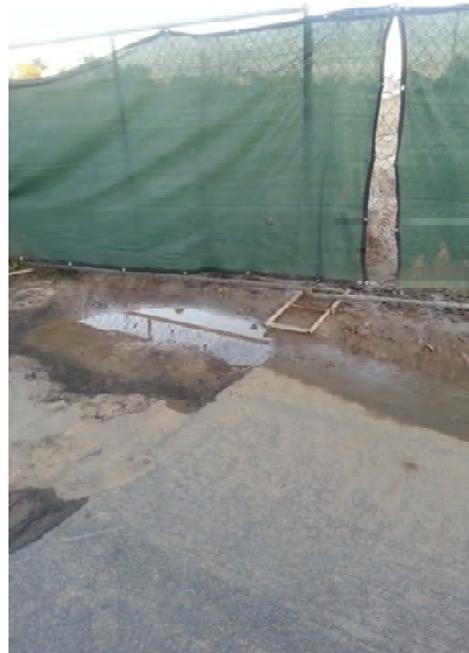
Photo 10 – No perimeter controls and no sediment controls. No silt fence present. No fiber rolls present. No vegetation present. Evidence of non-storm water discharge as seen in puddle of water and sediment staining on Oak Ave.

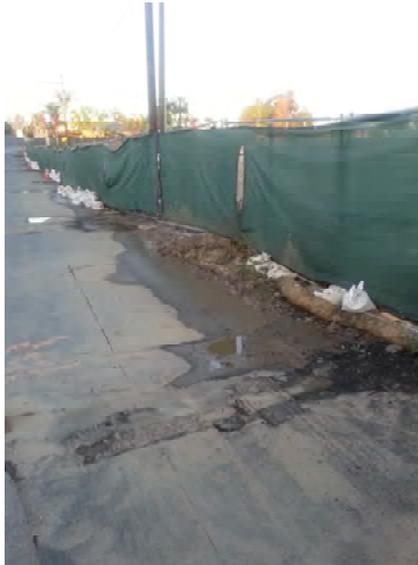
Photo 11 – Inadequate and ineffective perimeter controls and sediment controls. Evidence of a failure to require proper installation and proper maintenance of sediment controls. Evidence of non-storm water discharges from the site as seen in the pooled water and sediment staining on Oak Ave.

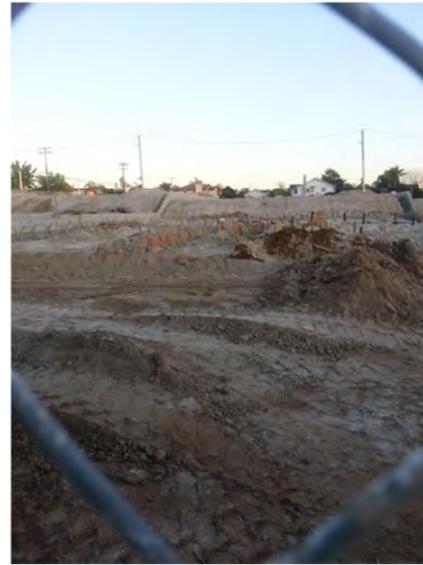
Photo 12 – Sitewide lack of soil stabilization, erosion controls, sedimentation controls. No hydroseed present. No fiber rolls present. No straw mats present. No silt fence present. Evidence of erosion present on interior slopes.

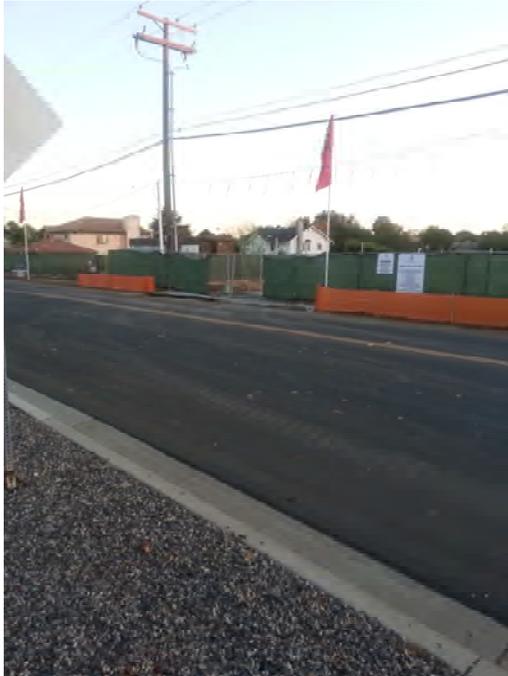
Photo 13 - Silt fence providing sediment controls and perimeter control along Valley Street side of the project. It is unclear if there is appropriate additional controls are present inside the fence line.

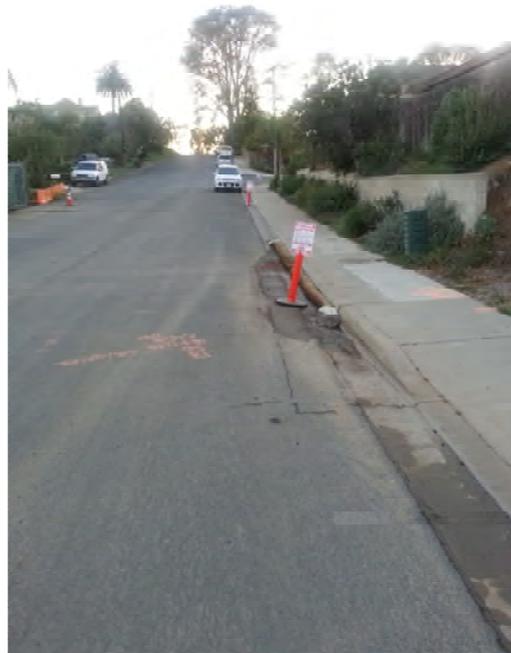
Photo 14 – Sediment staining on Oak Ave across the street from the site. Sediment collected near storm drain inlet. Street is wet indicating a presence of water and may have been result of street washing activities. Street still wet at the time this photo taken.

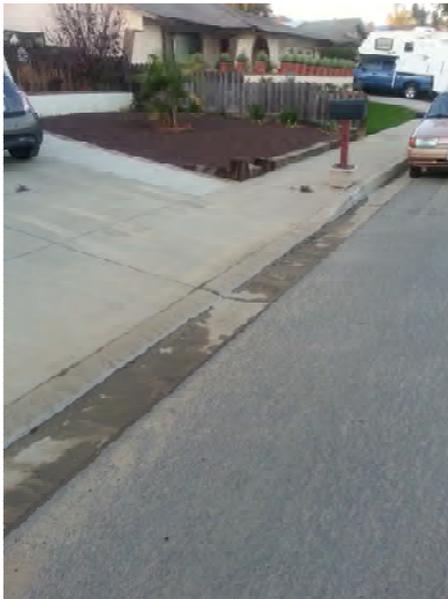
Photo 15 – Wet MS4. Sediment in MS4. Sediment on driveway after car tracked through it. Condition of the MS4 an indication that sediment is not adequately controlled on site.
