INSPECTION REPORT – VALLEY WATER MANAGEMENT COMPANY, FEE 34 FACILITY, EDISON OIL FIELD, KERN COUNTY

FACILITIES INSPECTION REPORT

VALLEY WATER MANAGEMENT COMPANY <small>DISCHARGER NAME</small>	EDISON OIL FIELD, FEE 34 C-PLANT <small>FACILITY NAME</small>
7500 MEANY AVENUE <small>STREET ADDRESS</small>	SW ¼ SECTION 34, T29S, R29E, MDB&M <small>STREET ADDRESS</small>
BAKERSFIELD, CA 93308 <small>CITY, STATE, ZIP CODE</small>	EDISON, KERN COUNTY <small>CITY, STATE, ZIP CODE</small>
LARRY BRIGHT <small>DISCHARGER CONTACT PERSON</small>	RUSSELL EMERSON <small>FACILITY CONTACT PERSON</small>
(661) 410-7500 <small>TELEPHONE NO.</small>	(661) 978-0982 <small>TELEPHONE NO.</small>
lbright@vwwater.com <small>E-MAIL ADDRESS</small>	remerson@vwwater.com <small>E-MAIL ADDRESS</small>

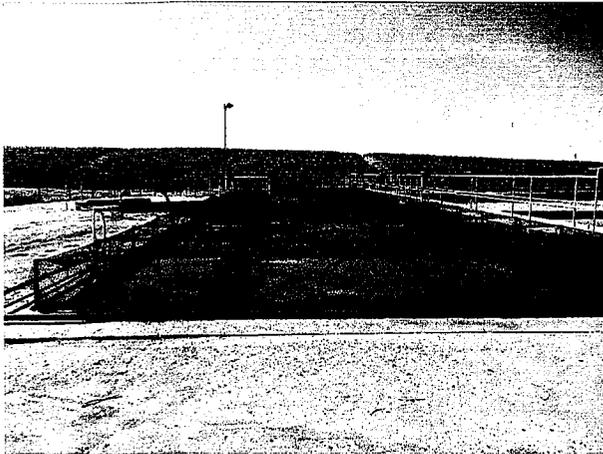
- Two Oil Separation Ponds
 - gunite-lined ponds with netting, containing oil and wastewater
 - inadequate freeboard, less than 2 feet
- Two Wastewater Ponds

Photo 1. – Netted Oil Separation Ponds looking south

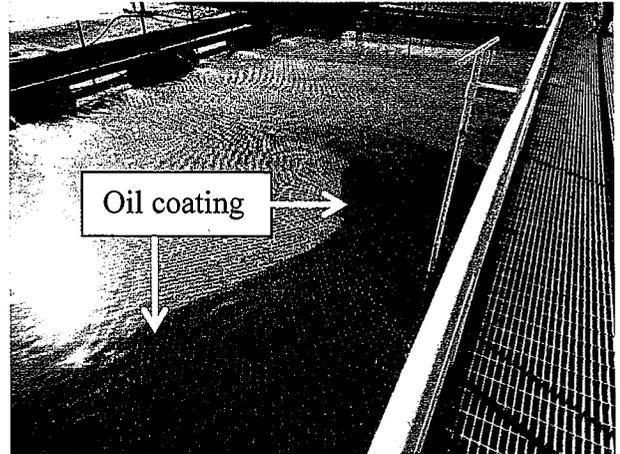
1. The two Oil Separation Ponds and the two Wastewater Ponds have insufficient freeboard (less than two feet) and are in violation of WDRs. Discharge Specification B. 6 of the WDRs states that a minimum of two feet of freeboard shall be maintained in all ponds.

Photo 2. – Oil in the Oil Separation Ponds

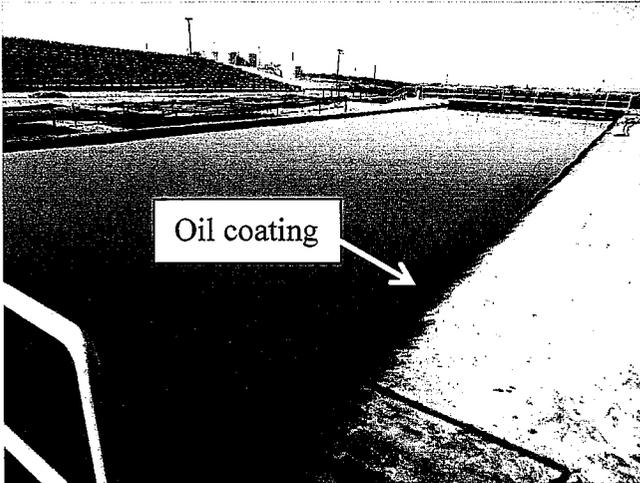
- gunite-lined pond with no netting, containing oily-wastewater
 - according to Mr. Emerson skimmers are used twice per day to remove oil from these ponds

- field readings from water taken from the southern wastewater pond were as follows;
 Conductivity (EC) 5,427 μS , pH 7.21, Temperature 25.5°C
 - inadequate freeboard, less than 2 feet

2. Oily-wastewater observed within the two Wastewater Ponds (See Photos 3 & 4) is a violation of WDRs. Discharge Specification B. 4 of the WDRs states that ponds shall be free of oil coatings or be covered or screened to preclude entry of bird or animal life. These two ponds need to be netted.

Photo 3. – Wastewater Pond (southern) looking southwest

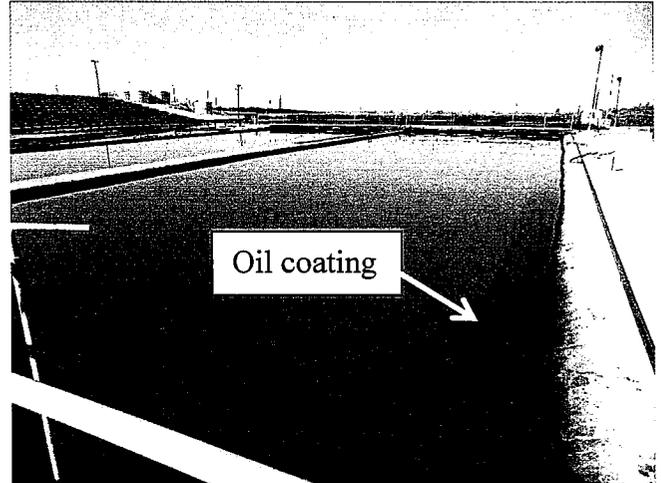
Photo 4. – Wastewater Pond (northern) looking southwest

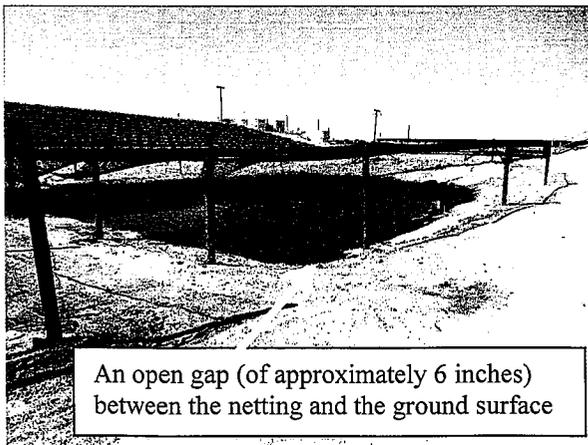
- inadequate netting (See Photo 5)
 - freeboard appears adequate
- One Containment Pond (referred to as a Stormwater Basin)
 - an unlined pond with no netting

3. The two Oil Ponds have insufficient netting (See Photo 5) and are in violation of WDRs. Discharge Specification B. 4 of the WDRs states that ponds shall be free of oil coatings or be covered or screened to preclude entry of bird or animal life.

Photo 5. – Oil Pond (western) looking southwest

By 15 May 2015, please submit documentation describing measures completed to address the netting repairs, including before and after photos.

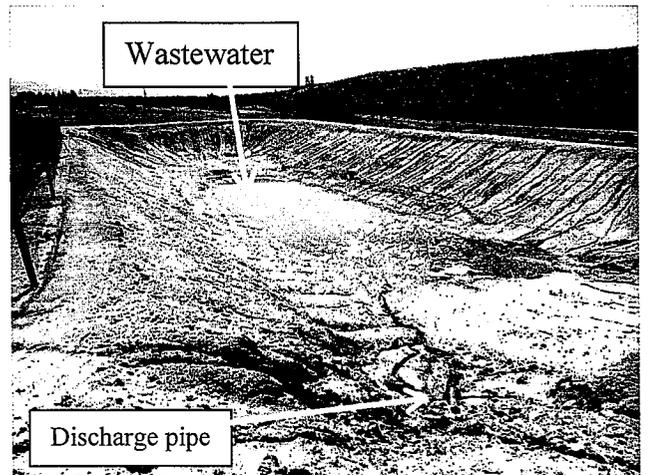
- contains wastewater
 - Mr. Emerson state that the water in the pond was production wastewater
 - field readings of water taken from the pond were as follows;
 EC 3,975 μS , pH 8.38, Temperature 22.6 °C

- no oil was observed in the pond
 - freeboard appears adequate

Photo 6. – The Storm Water Basin looking southeast
