NOTICE OF VIOLATION

**INSPECTION REPORT – VALLEY WATER MANAGEMENT COMPANY, C-PLANT FACILITY,
EDISON OIL FIELD, KERN COUNTY**

FACILITIES INSPECTION REPORT

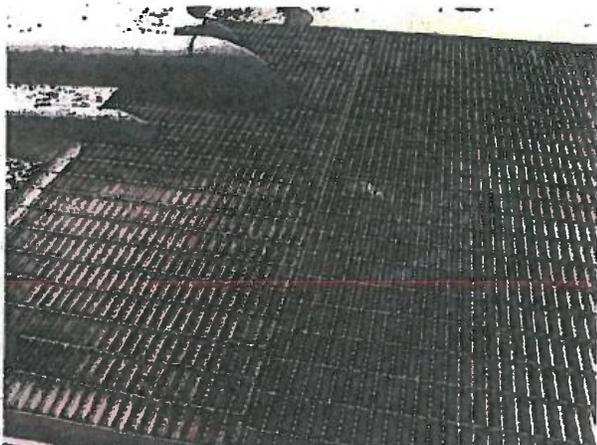
Wastewater enters the facility by means of inlet pipes (Photograph 1). The inlet pipes discharge wastewater into two oil separation sumps that are covered with netting (Photograph 2). The oil separation sumps are gunite-lined and contained wastewater coated with crude oil. From the oil separation sumps, the wastewater enters two gunite-lined sumps (hereafter referred to as "wastewater sumps") that are each approximately 125 feet in length and 45 feet wide (Photographs 3 and 4). The two wastewater sumps are equipped with built-in skimmers, that when lowered by an operator, skim crude oil off the wastewater. I did not observe any crude oil in the wastewater sumps (Photograph 4). Both of the wastewater sumps appeared to have insufficient freeboard (approximately 1 foot of freeboard). There are two unlined sumps (hereafter referred to as "oil sumps") that are used for storage of crude oil that is skimmed from wastewater. The two oil sumps were at maximum capacity and contained wastewater coated with a thin veneer of crude oil (Photograph 5). The last sump in the series is gunite-lined and is referred to as the shipping sump. Netting was recently constructed over the shipping sump to prevent wildlife from contacting crude oil (Photograph 6). The shipping sump contained wastewater coated with some crude oil near the northeast corner of the sump.

Photograph 1. – View of incoming wastewater pipes that discharge into the separation sumps.

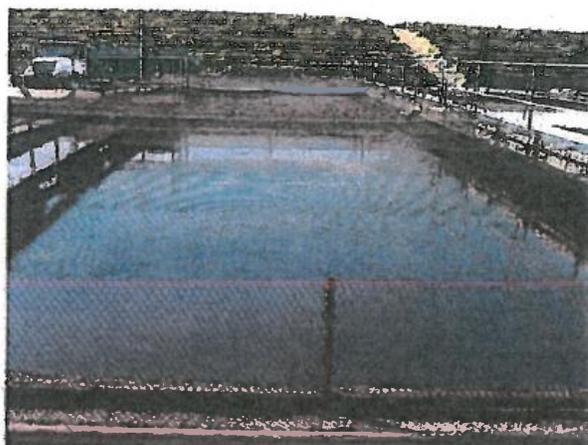
Photograph 2. – View of oil separation sumps.

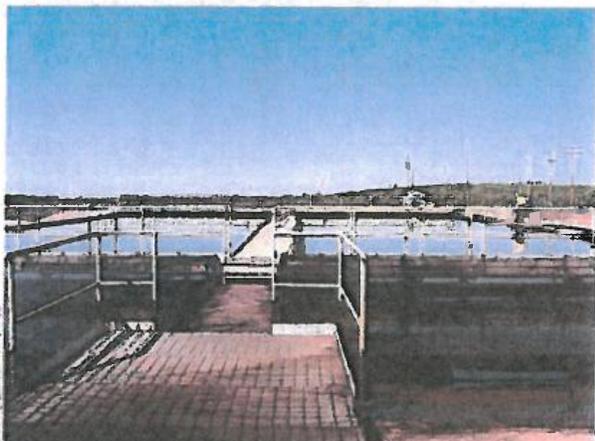
Photograph 3. – View of a separation sumps and wastewater sumps looking west.

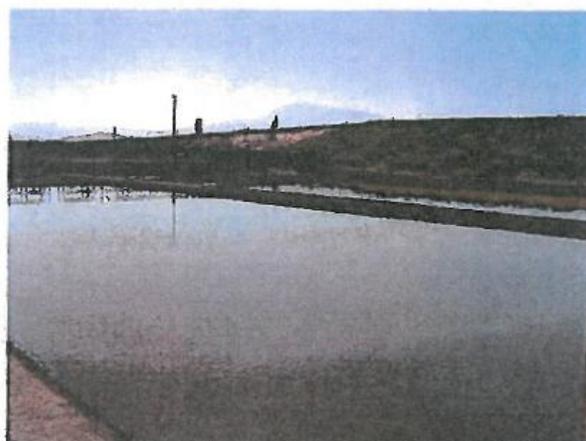
Staff observed that oil field produced wastewater was being discharged into seven surface impoundments (sumps) at the facility. Two sumps (referred to as wastewater sumps; see Figure 1) appeared to have insufficient freeboard (approximately 1 foot of freeboard) and are in violation of the WDRs. Waste Discharge Specification B.6 of the WDRs states that a minimum of two feet of freeboard needs to be maintained in the sumps. The final sump in the series has recently been covered with netting to preclude wildlife.

2. The two wastewater sumps appeared to have insufficient freeboard (approximately 1 foot) and are in violation of the WDRs. Waste Discharge Specification B.6 of the WDRs states that a minimum of two feet of freeboard needs to be maintained in the sumps.

Photograph 4. – View of the wastewater sumps looking southeast.

4. Discharge of high salinity wastewater to sumps at the facility is a violation of the WDRs and poses a threat to groundwater. The disposal of wastewater to sumps at the facility needs to cease.

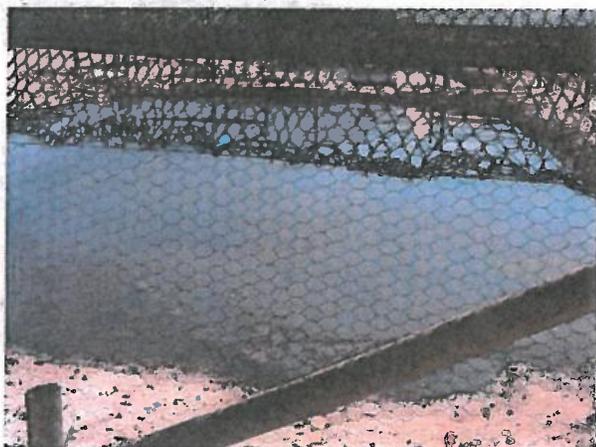
Photograph 5. – View of the two unlined oil sumps.

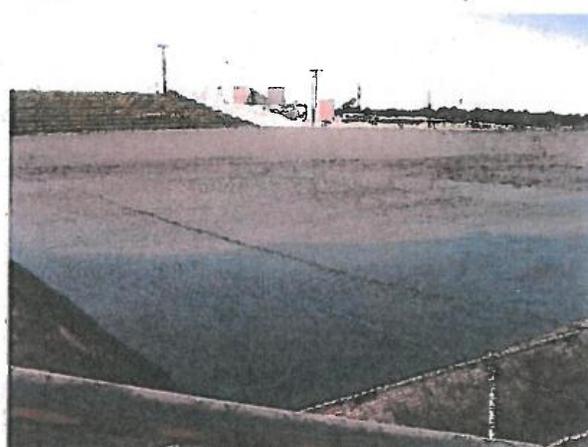
1. The shipping sump has recently been covered with netting to preclude wildlife. This resolves the Notice of Violation dated 28 June 2012 issued to Valley Water Management Company.

Photograph 6. – View of the shipping sump.

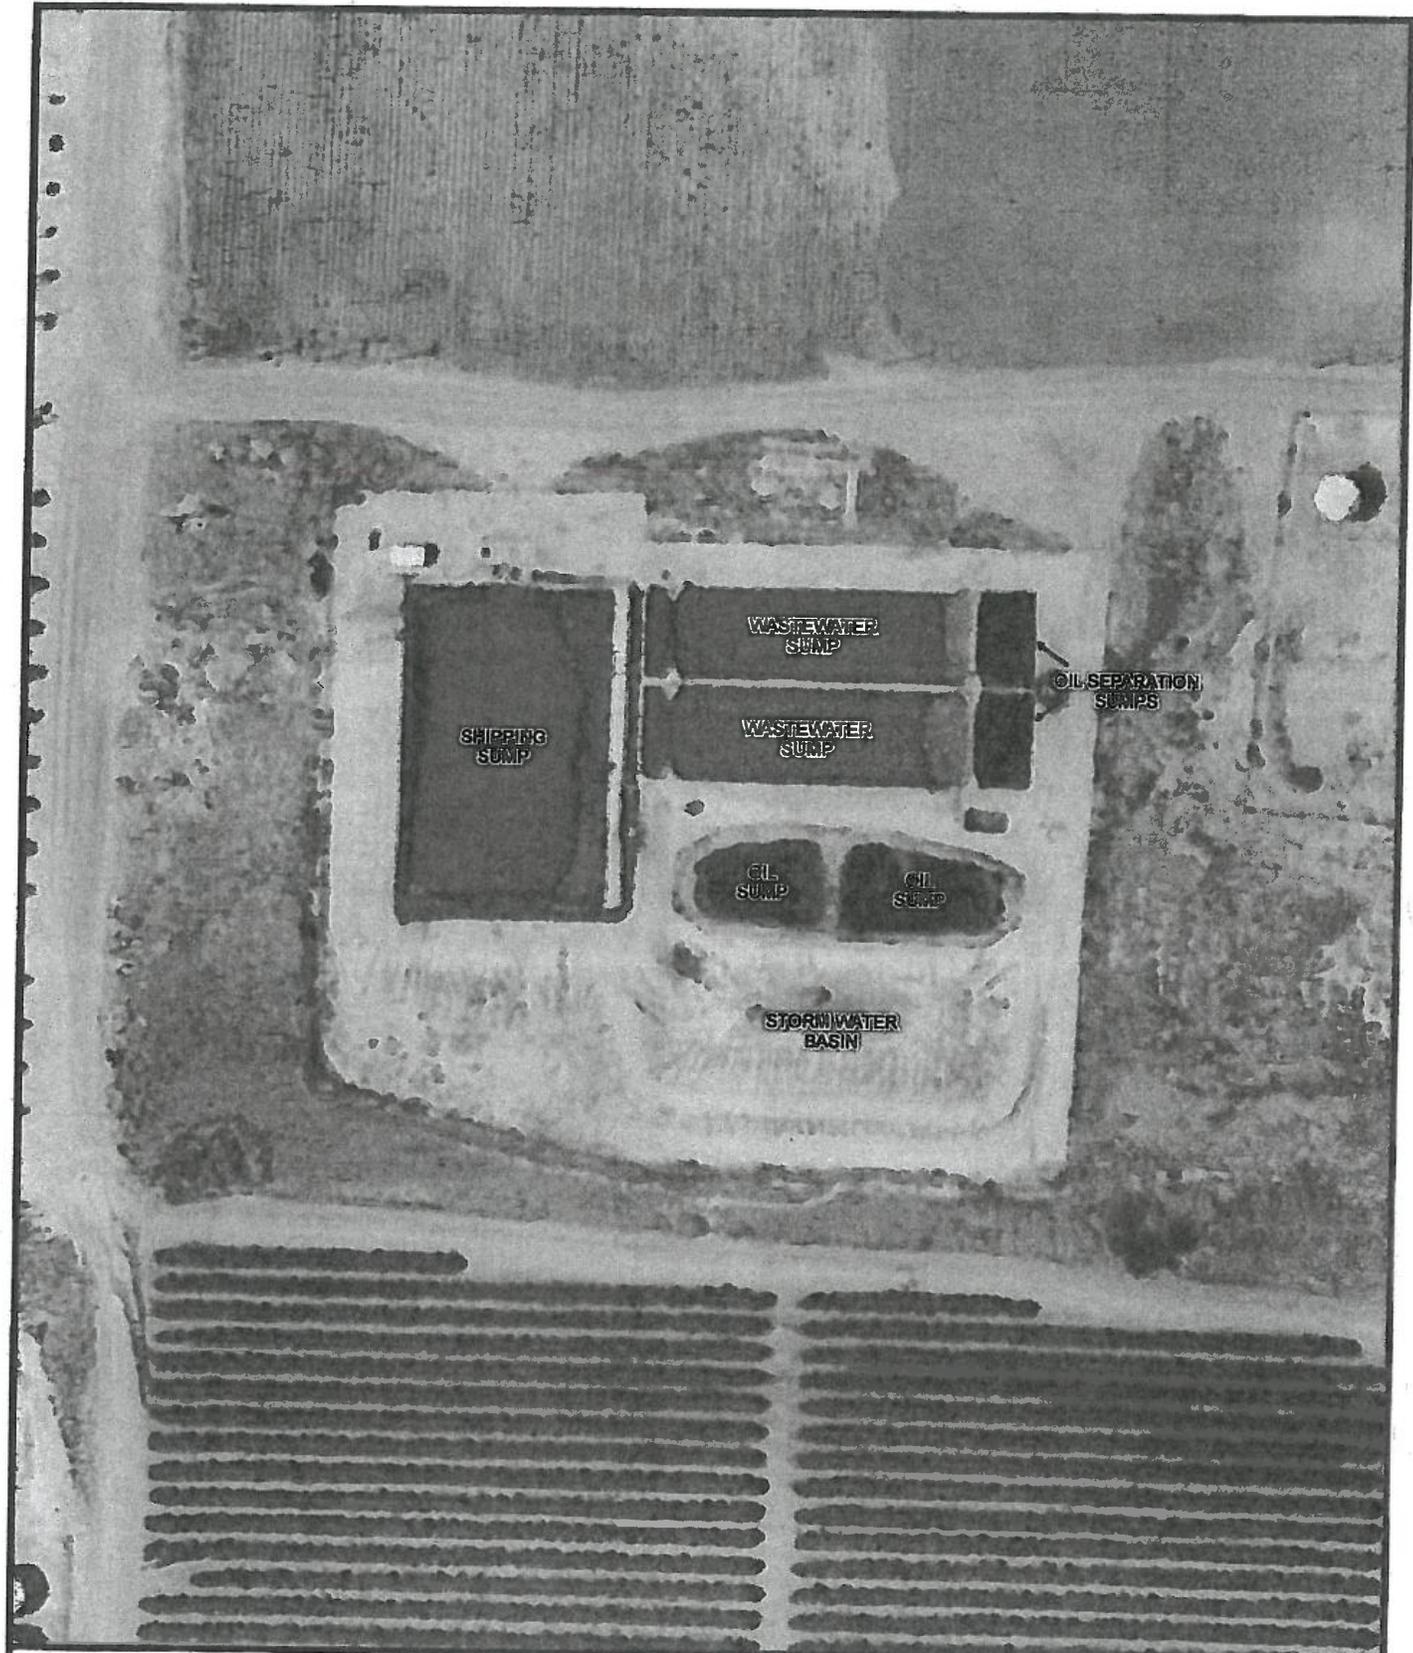
FIGURE 1

The C-Plant Facility (Figure 1) contains seven sumps that are used for oil separation and storage of oil field production wastewater. The C-Plant Facility accepts approximately 4.5 million barrels (189 million gallons) of oil field production wastewater per year from several small oil producers in the Edison Oil Field whose wastewater does not meet Basin Plan salinity limits for discharges to unlined sumps. The wastewater contains an electrical conductivity (EC) of 5,700 micromhos per centimeter ($\mu\text{mhos/cm}$), a chloride concentration of 1,800 milligrams per liter (mg/L), and a boron concentration of 14 mg/L. Wastewater from the C-plant Facility is piped to Valley Water Management Company's Race Track Hill Facility for disposal to unlined sumps.

Staff observed that oil field produced wastewater was being discharged into seven sumps at the facility. Land in the immediate vicinity of the facility is used for farming. It appeared that grapes are being farmed immediately south of the facility (see Figure 1).

SITE MAP
ORDER NO. 92-11037
VALLEY WATER MANAGEMENT COMPANY
EDISON FEE 34 (RACETRACK HILL, C-PLANT) FACILITY
KERN COUNTY
