Aerial photo showing the Reeve Road Heifer Ranch and the Henry Tosta Dairy located just north of Tracy, CA.

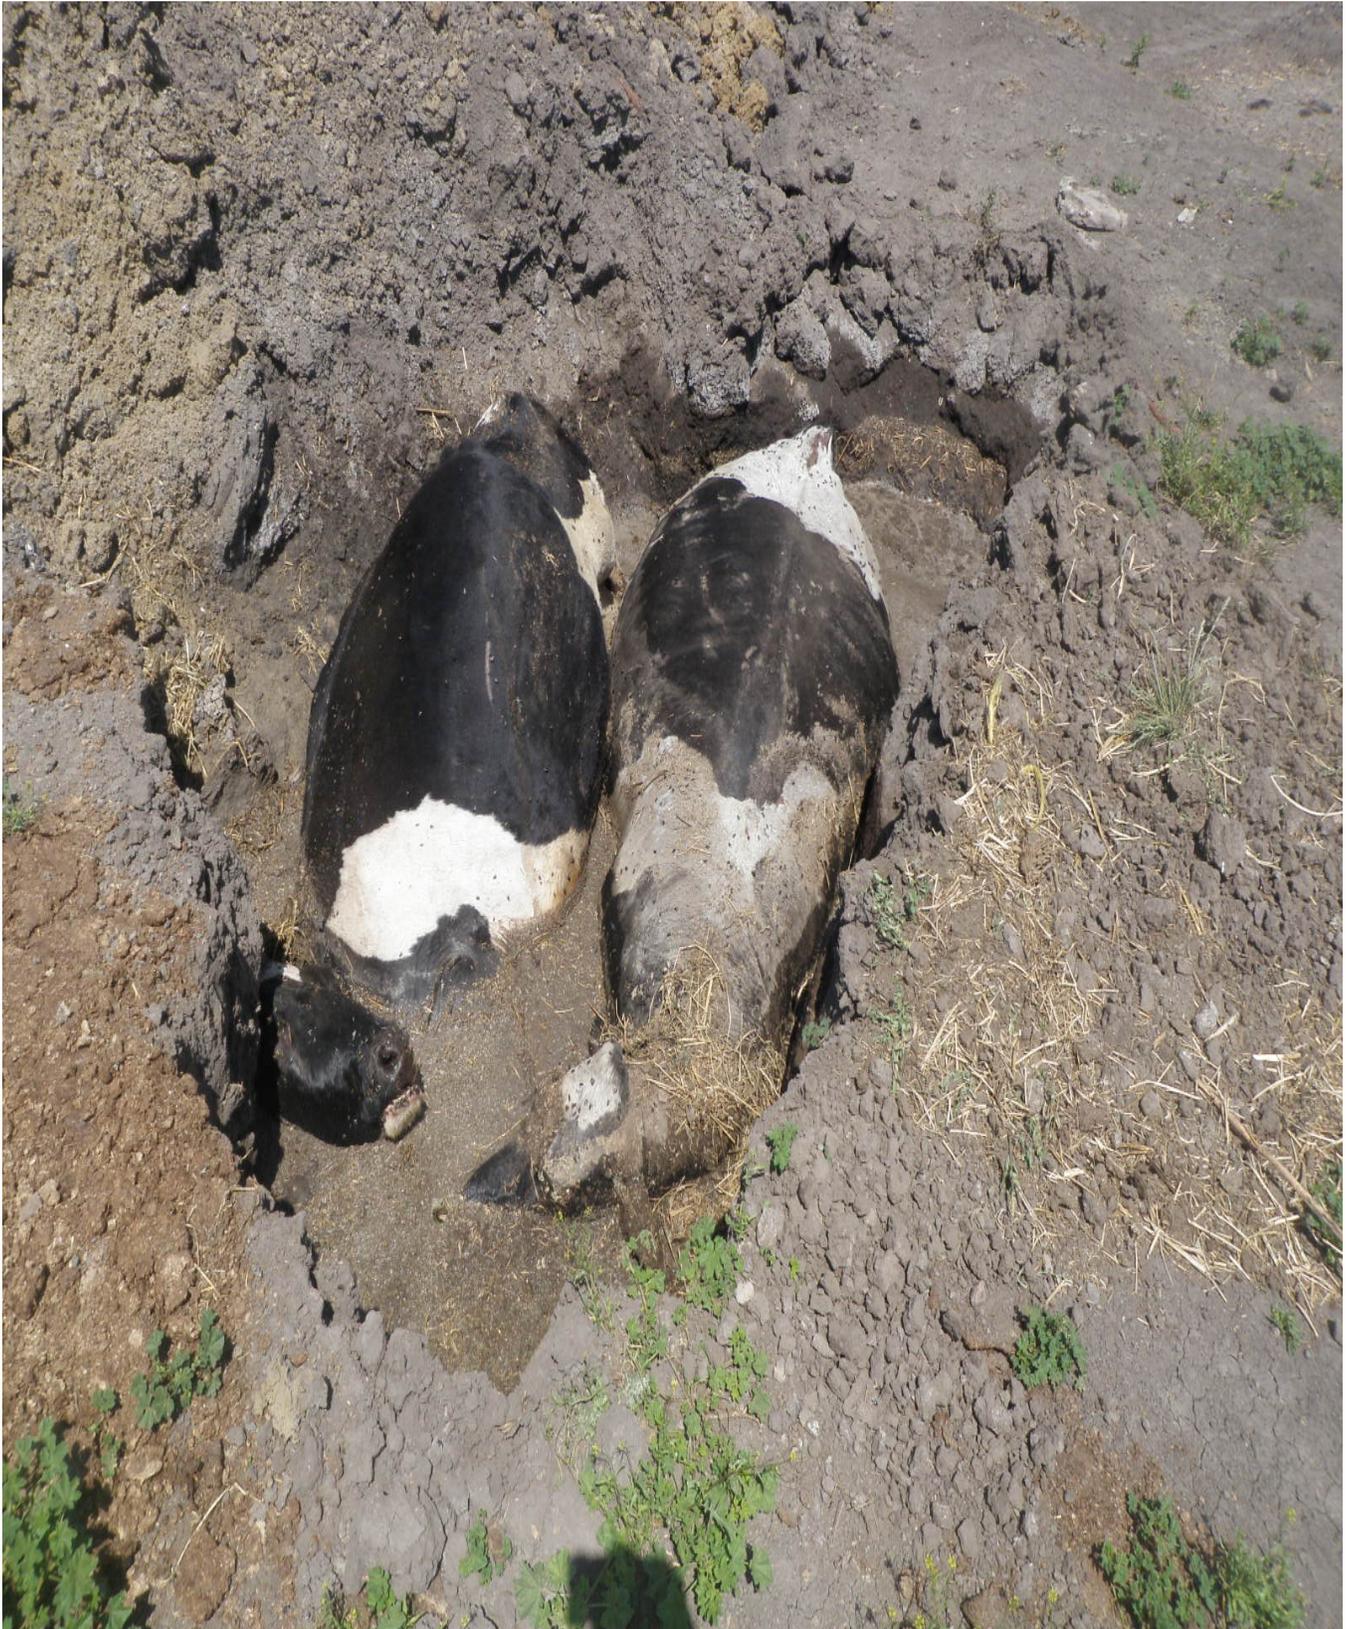
During the 1 May 2012 inspection, cow carcasses were found both above ground surface and in an open grave. Note the dead cows are submersed in groundwater.

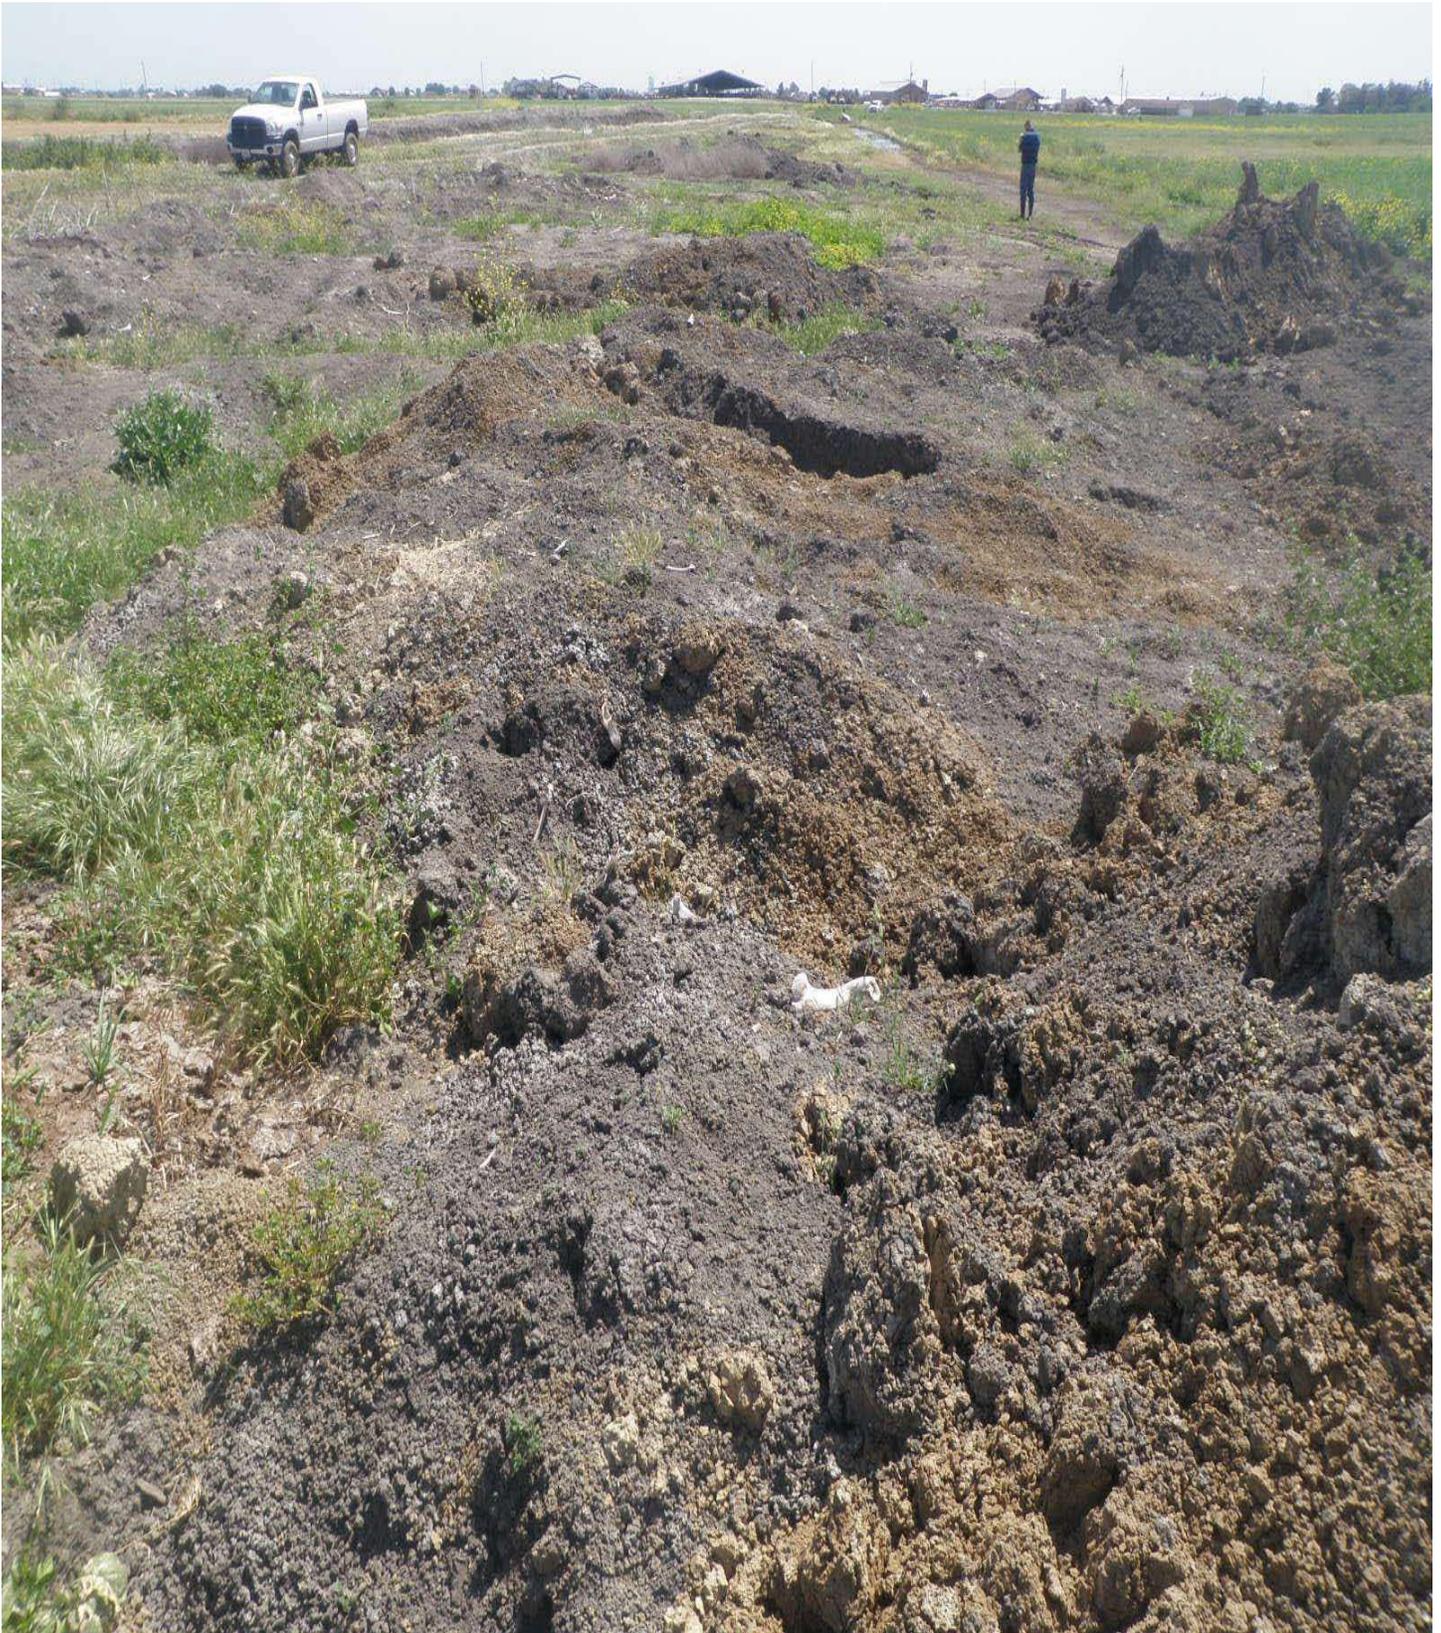
Photo of the cow burial area located on the Reeve Road Heifer Ranch's cropland just south of the Naglee-Burk Irrigation District's Canal. Dead cows from the Henry Tosta Dairy were being buried in shallow graves.

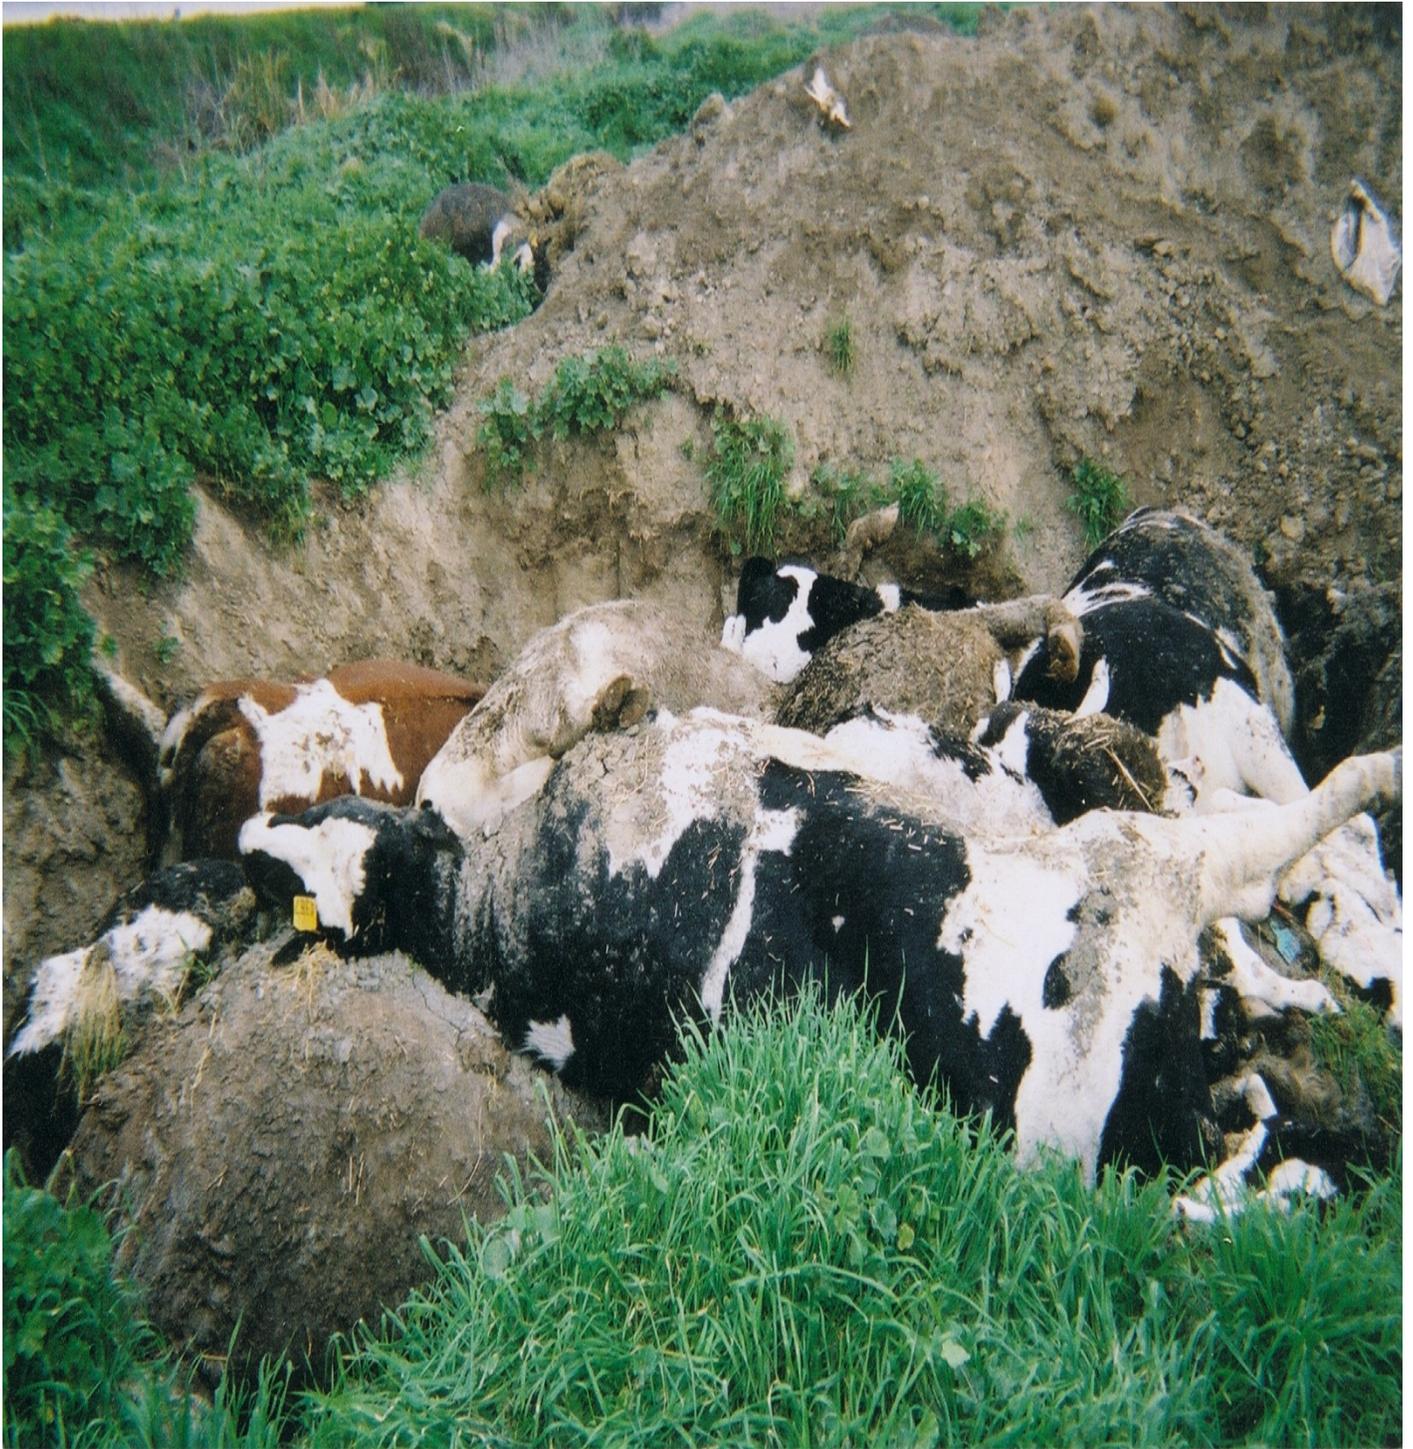
Photo of cow carcasses placed in a shallow grave on Heifer Ranch cropland managed by Mr. Henry Tosta.

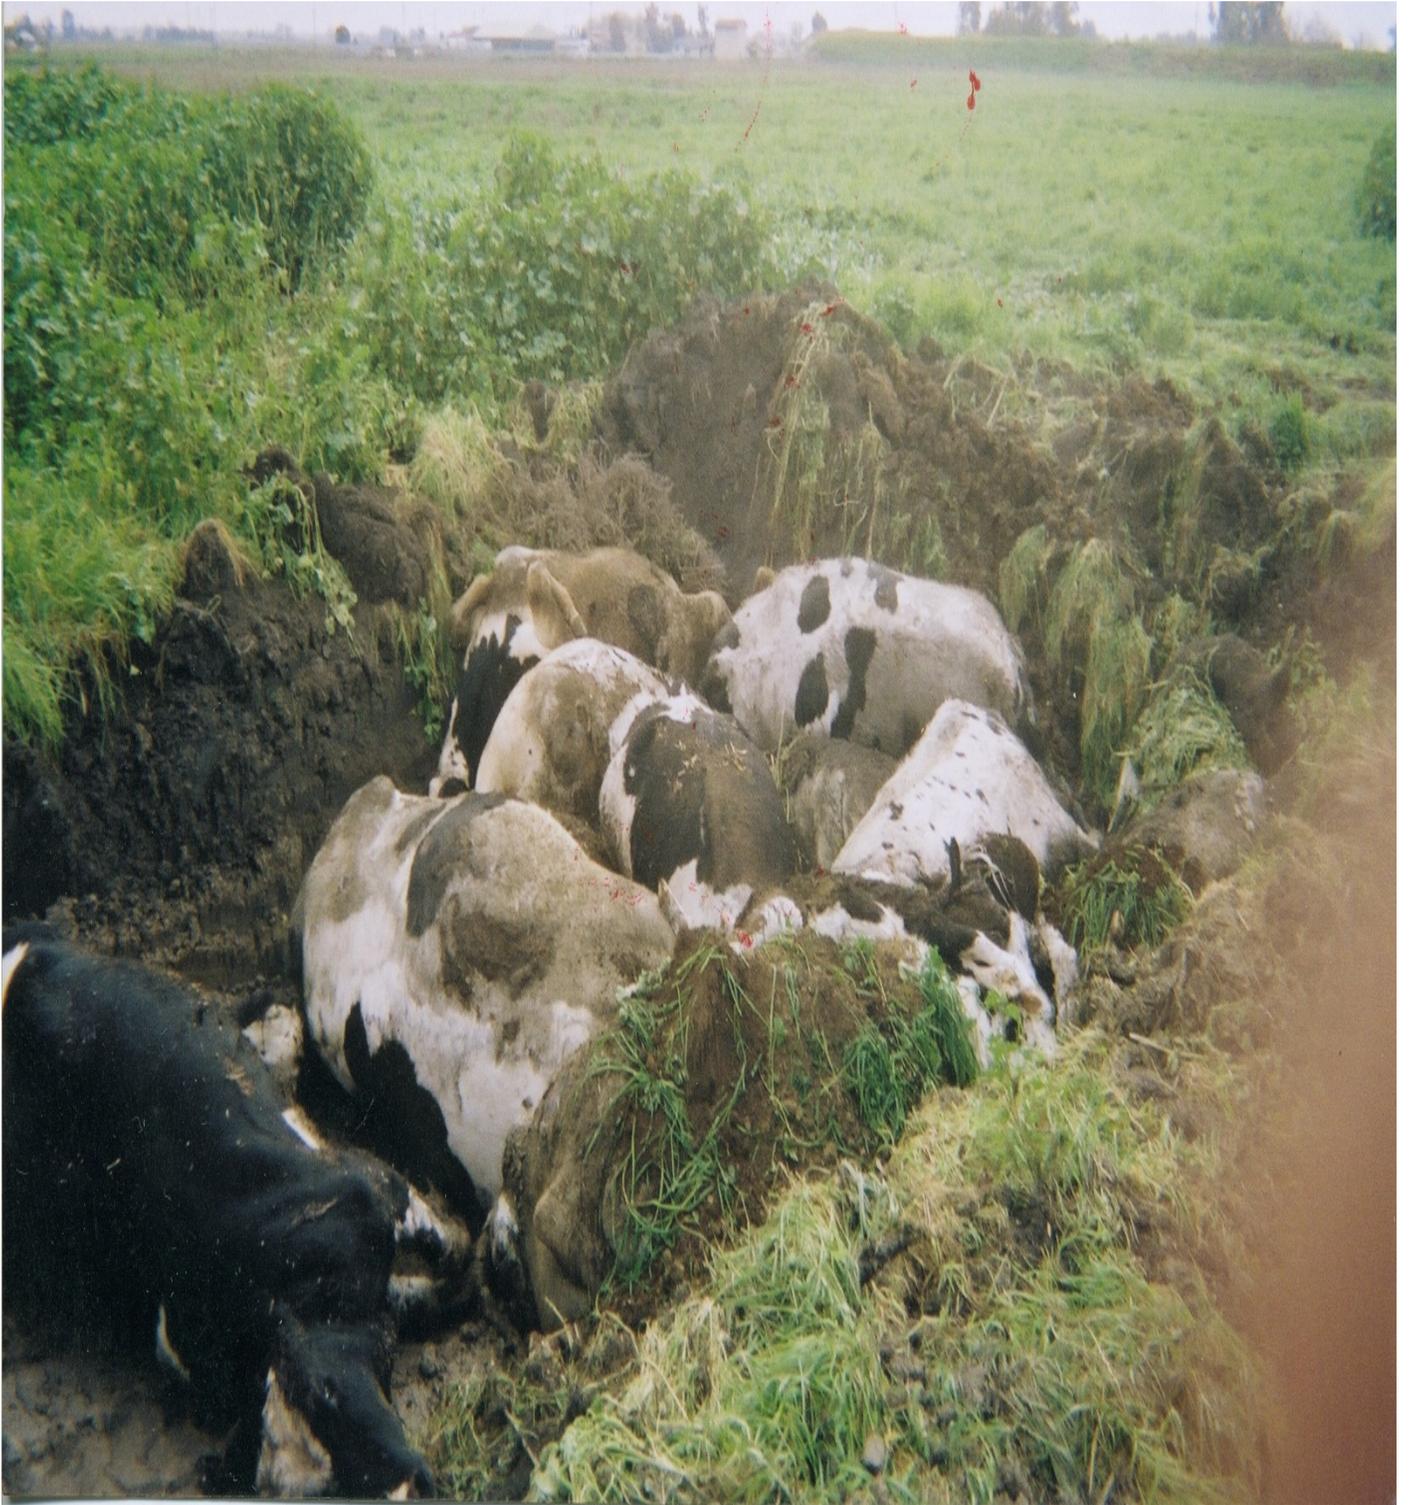
Different photo of cow carcasses placed in a shallow grave on Heifer Ranch cropland managed by Mr. Henry Tosta.

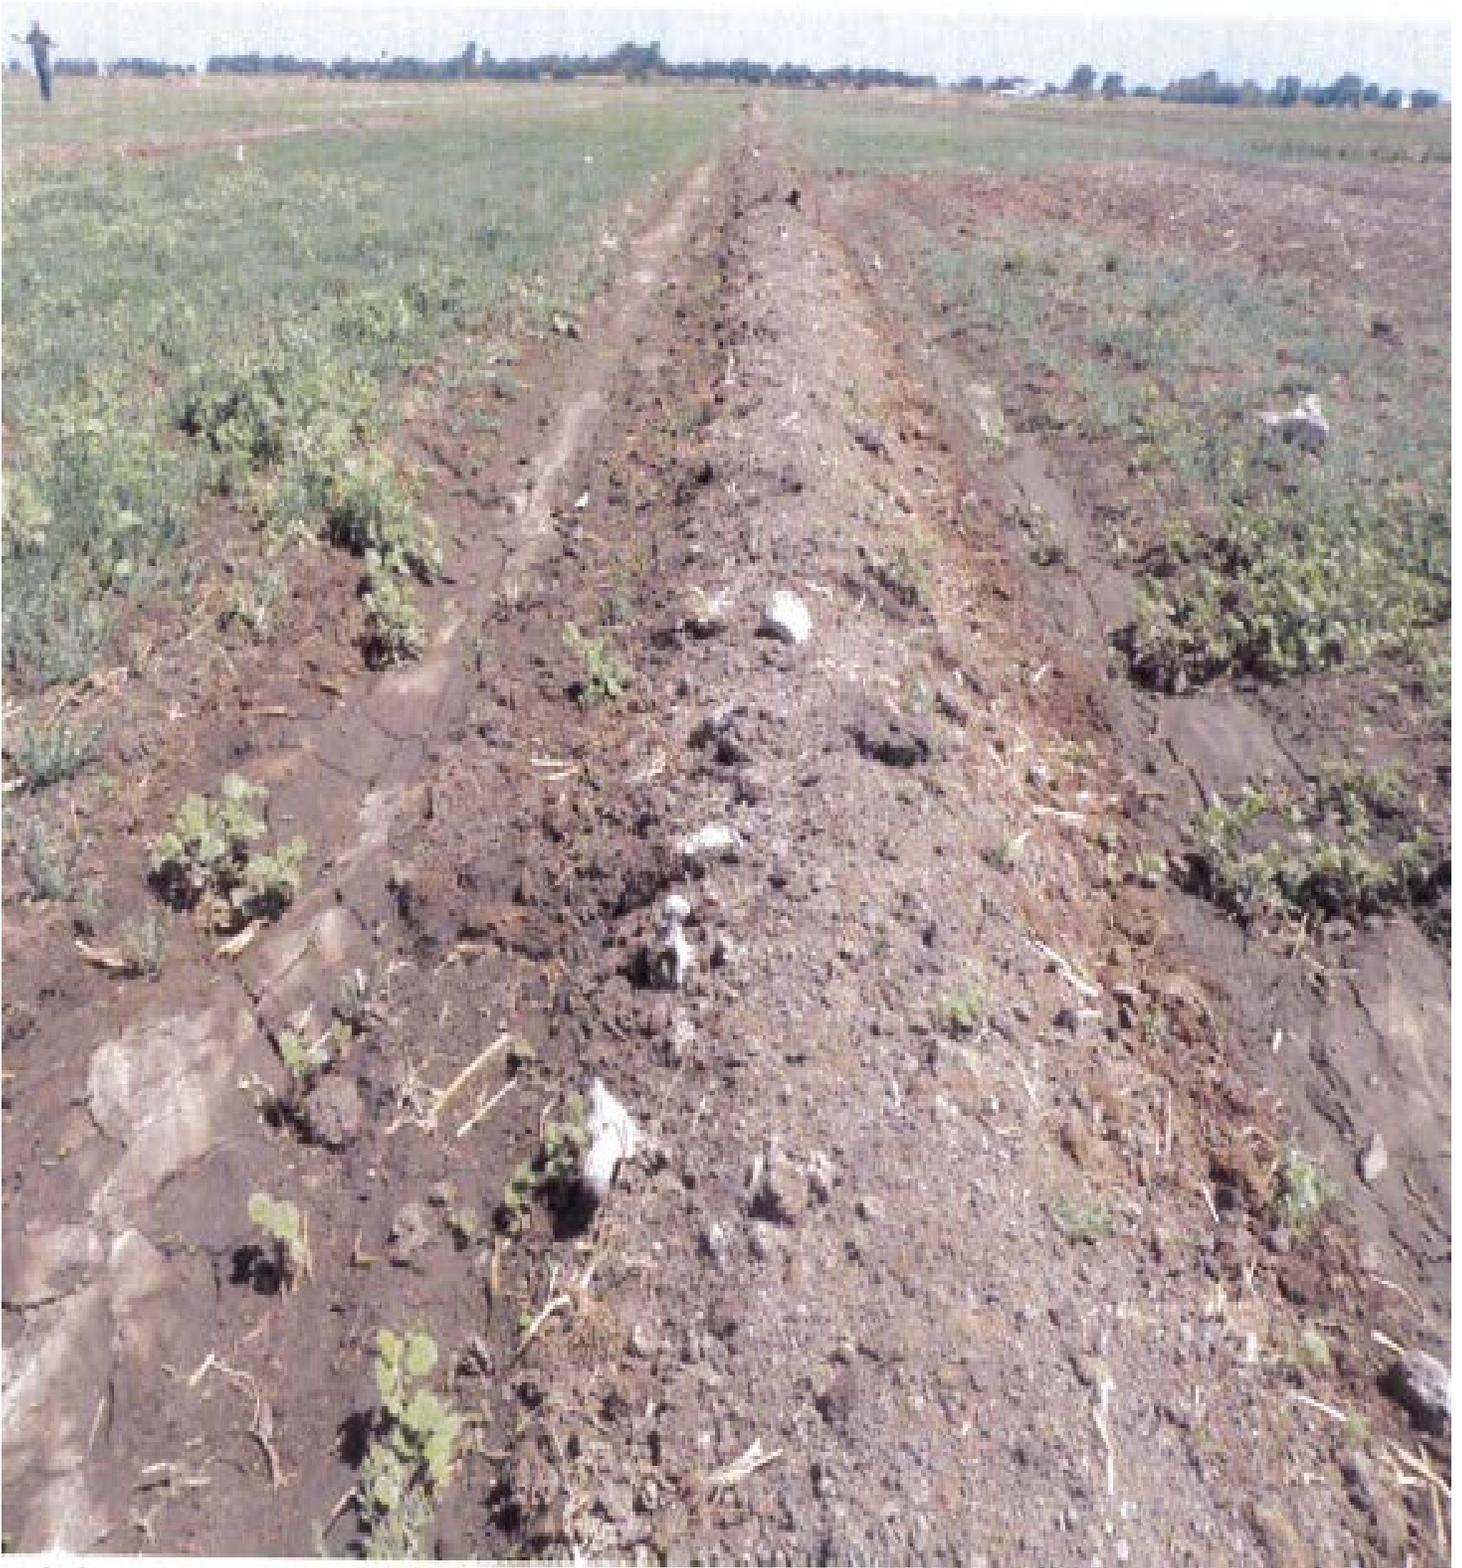
Photo of cow bones scattered on Reeve Road Heifer Ranch cropland.

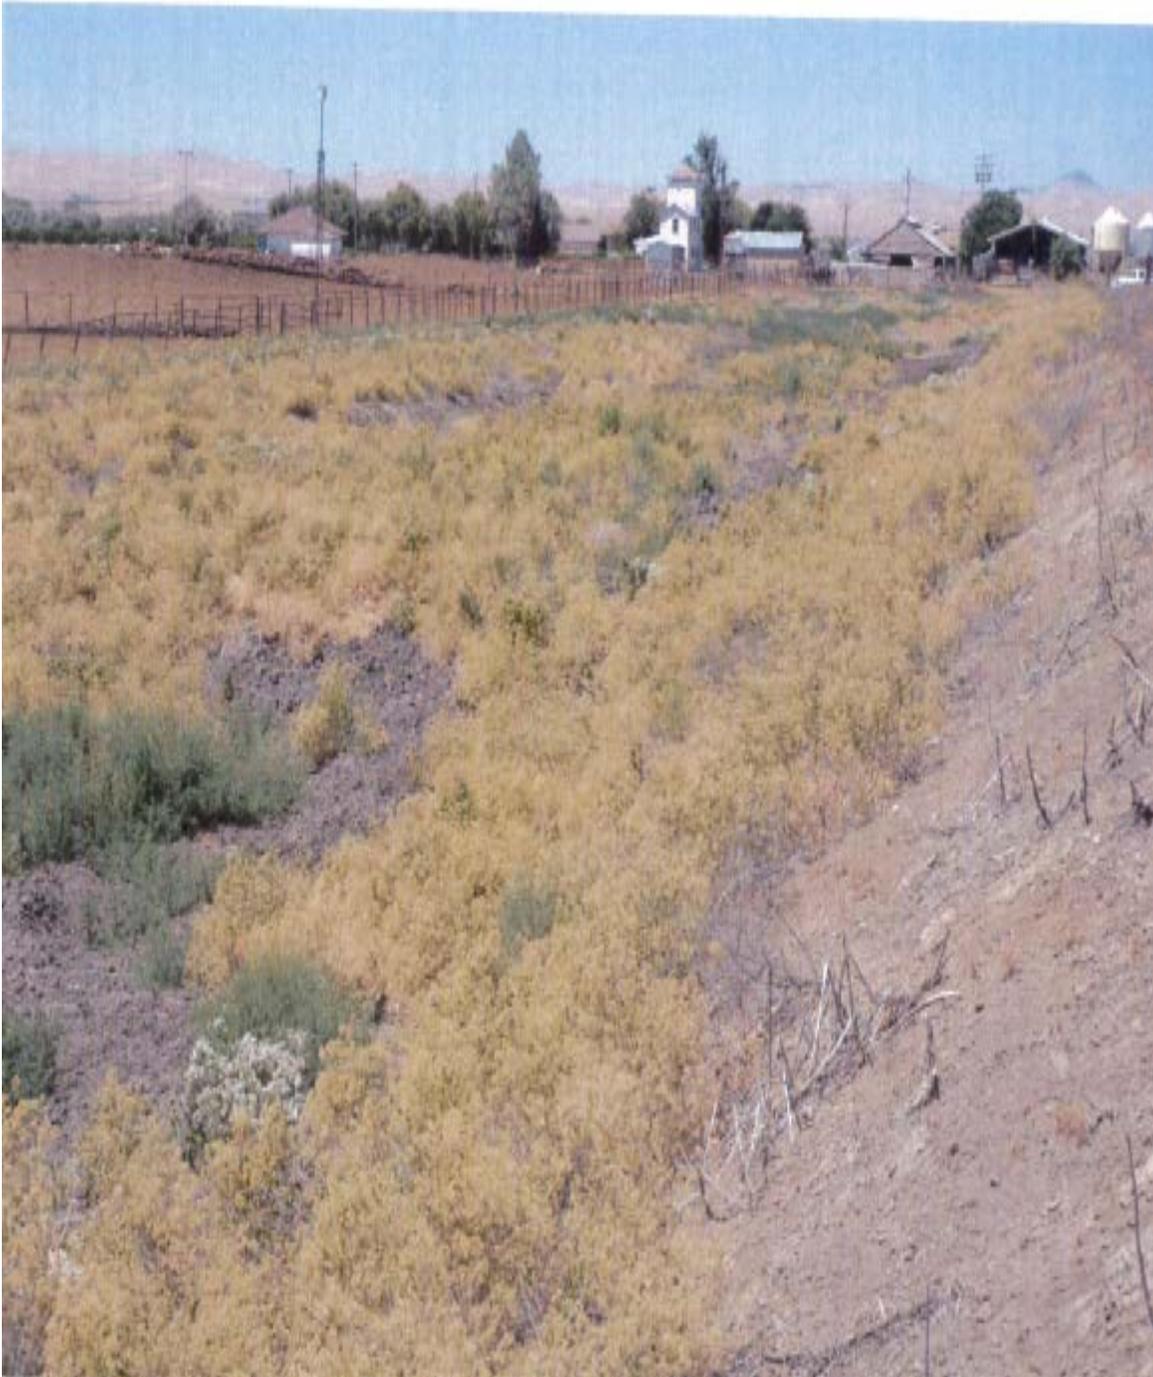
Photo of an area south of the wastewater storage lagoon in the Heifer Ranch production area where cows were buried in manure in the past. Bones are mixed throughout the manure.
