California Regional Water Quality Control Board, San Diego Region

Subject: Notice of Violation No. R9-2015-0056 and Water Code Section 13267 Request for Technical Report, City of Carlsbad

**NOTICE OF VIOLATION
No. R9-2015-0056**

Facility: Robertson Ranch
Inspection Date: 12/12/2014

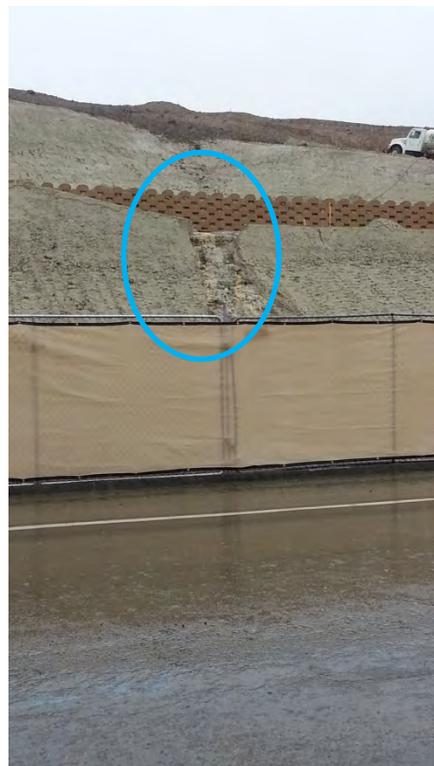
Photo 8: Slopes lacking adequate erosion and sediment control BMPs; erosional gully shown in photo.

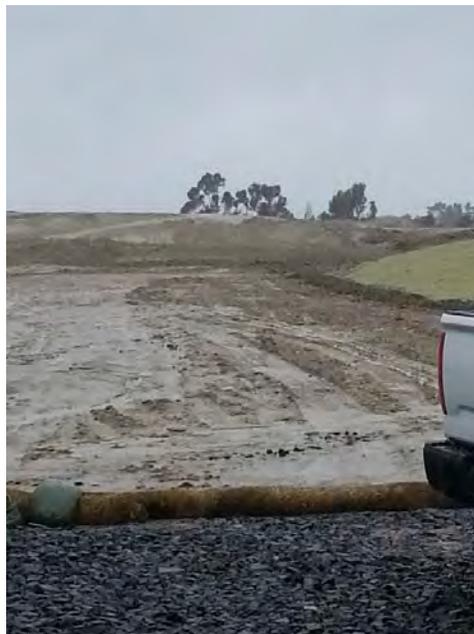
Photo 13 No erosion in conjunction with sediment controls present on other areas of site in this photo. No protection on large open areas of excavated land shown in back of photo.

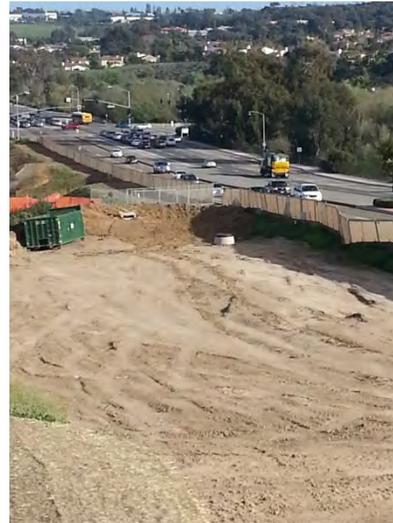
Photo 6: Waste bin not covered to provide protection from wind and rain. No evidence of cover nearby indicating that the container is covered at the end of each workday.

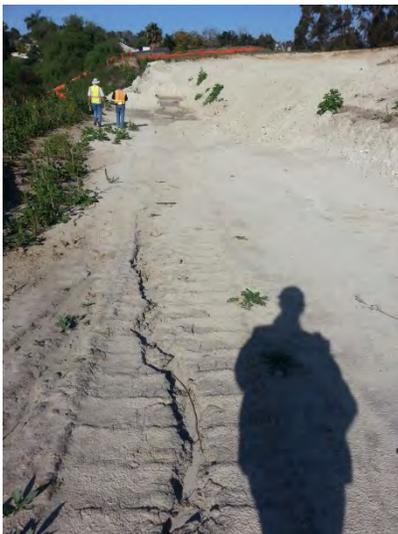
Photo 7: Signs of erosion on inactive areas of the site. Portion of the site without erosion or sediment control BMPs even though it has been inactive for more than 14 days (CGP requirement) which also exceeded the City's 10 day definition of inactive.

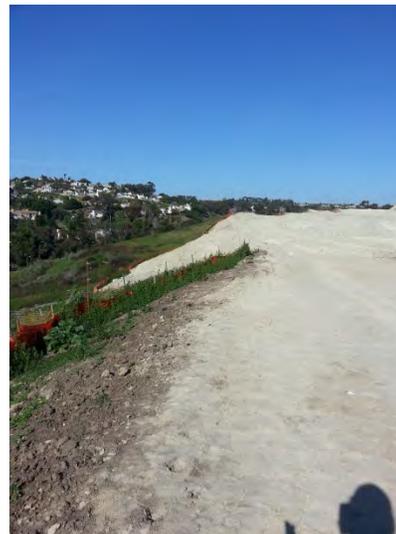
Photo 8: Large steep slopes along much of the perimeter of the site (this view is of the northern perimeter of the site parallel to Tamarack) without linear sediment controls or erosion controls. Portion of the site without erosion or sediment control BMPs even though it has been inactive for more than 14 days (CGP requirement) which also exceeded the City's 10 day definition of inactive. Silt fence is present at the toe of the slope that surrounds the perimeter of the site.

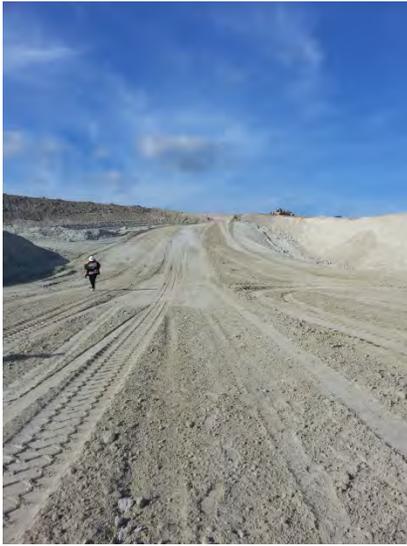
Photo 9: No erosion controls present on large slopes. No linear sediment controls on large slopes. No erosion in conjunction with sediment controls present on other areas of site.

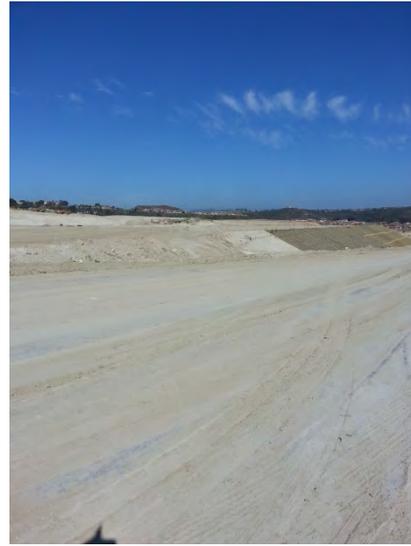
Photo 10 Partial erosion control present (i.e. straw blankets) on one large slope. Partial linear sediment controls on a part of the large slope in this photo. No erosion in conjunction with sediment controls present on other areas of site in this photo.

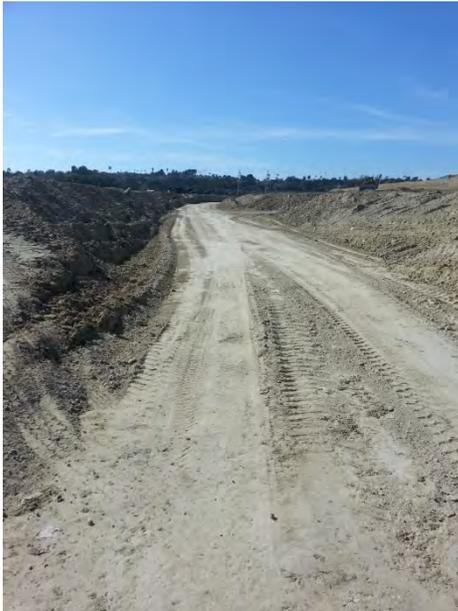
Photo 11 No erosion controls present on large slopes. No linear sediment controls on large slopes. No erosion in conjunction with sediment controls present on other areas of site.

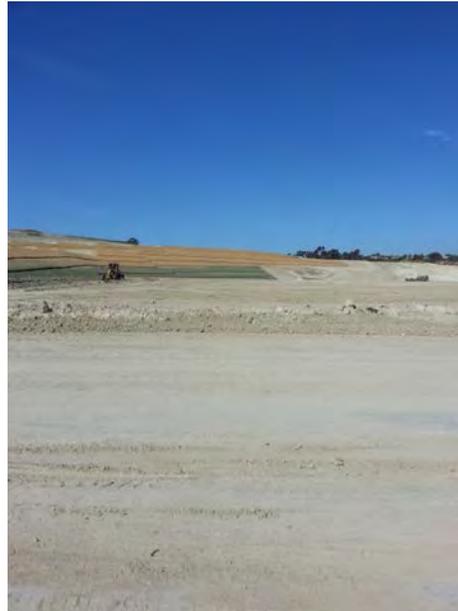
Photo 12 Erosion and sediment controls present only on those slopes that have reached final grade. No erosion in conjunction with sediment controls present on other areas of site.

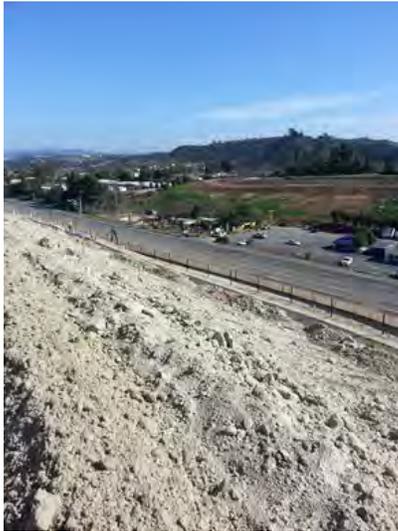
Photo 13 No erosion controls present on large slopes. No linear sediment controls on large slopes. No erosion in conjunction with sediment controls present on other areas of site.

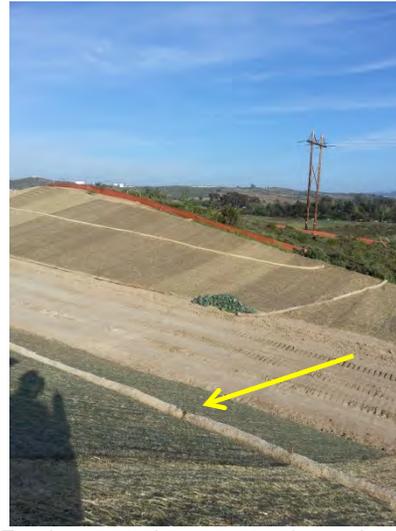
Photo 14 Erosion controls present only on slopes that have reached final grade. Linear sediment controls installed end to end and not overlapped per CASQA Construction BMP Handbooks. None of the fiber rolls on the site at the time of this inspection were installed with overlapping ends. It was unclear if the rolls were trenched in 4 inches.

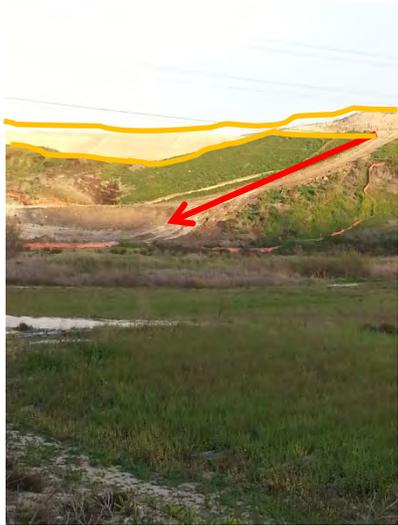
Photo 15 No erosion controls present on large steep slopes (red arrow). No linear sediment controls on large slopes steep slopes (outlined in orange). No erosion in conjunction with sediment controls present on either areas.

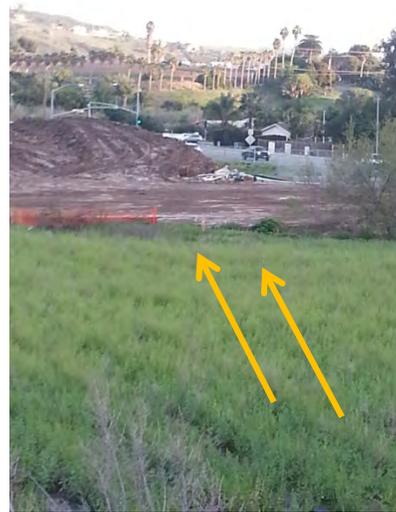
- a. **Pursuant to Provision X and Section F.1 of Attachment D of State Water Board Order No. 2009-0009-DWQ:** Risk Level 2 shall effectively manage all run-on, all runoff within the site and all runoff that discharges from the site. Run-on from off site shall be directed away from all disturbed areas or shall collectively be in compliance with the effluent limitations in the CGP.
- b. **Observation:** During the January 26, 2015 inspection, the San Diego Water Board inspector observed areas of the site unprotected from run-on. The northwestern portion of the site was not protected from run-on coming from El Camino Real. See attached February 26, 2015 Facility Inspection Report Photo 15.

Photo 16 No protection from run-on. Looking south onto the site this area is subject to run-on from El Camino Real and Tamarak (yellow arrows indicate plath of flow) At the time of this inspection (less than 48 hours prior to a rain event) this area was unprotected from run-in. The large soil stockpile was unprotected from wind and rain. The stockpile was not protected using soil stabilizers or bermed.

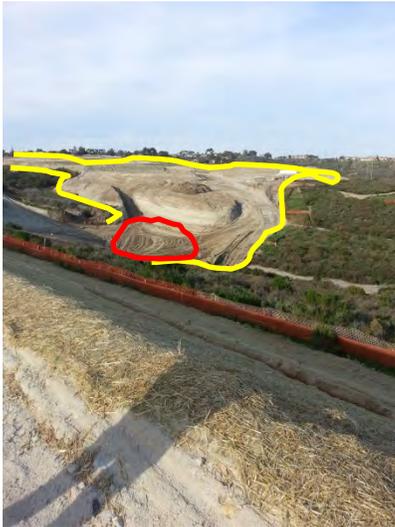
- c. **Observation:** During the February 26, 2015 inspection, the San Diego Water Board inspector observed sedimentation basins that were not designed in accordance with CASQA Construction BMP Guidance Handbook. The sedimentation basin created to retain runoff from the south east portion of the site was constructed prior to the QSD providing design calculations. See attached February 26, 2015 Facility Inspection Report Photos 17 and 18.

Photo 17 Large sediment basin (outlined in red) is the only BMP being relied upon to capture sediment and runoff from the approximately 45 acre portion of the site identified by the yellow line. At the time of this inspection this basin had not been designed in accordance with CASQA guidelines. No erosion controls present.

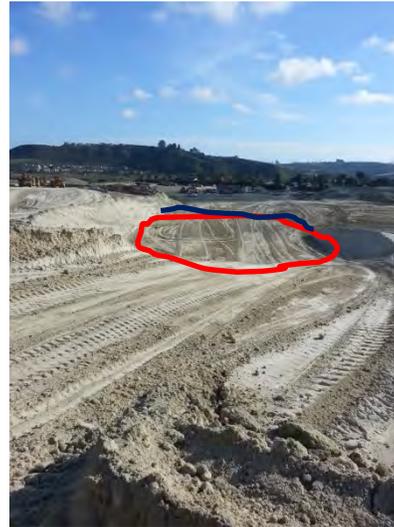
Photo 18 Large sediment basin (outlined in red) is the only BMP being relied upon to capture sediment and runoff from the surrounding area site shown in the photo. At the time of this inspection this basin had not been designed in accordance with CASQA guidelines. At the time of this inspection a berm to close off this basin (blue line) had not been constructed. No soil stabilization erosion controls are present. No linear sediment controls are in place on slopes. No erosion in conjunction with sediment controls present.

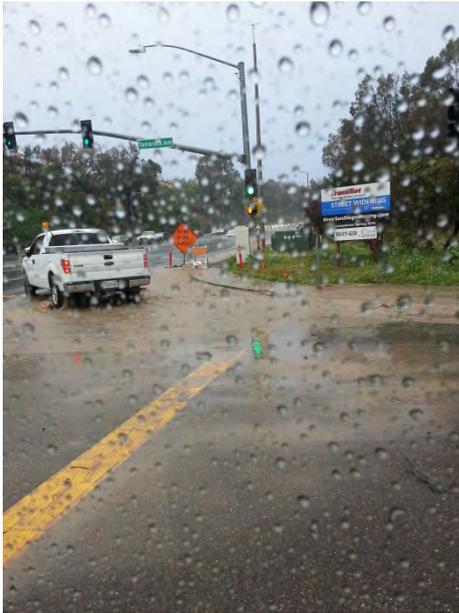
- c. Observation:** On March 2, 2014, the San Diego Water Board inspector observed a major discharge of sediment laden water to the MS4. See Attachment1 – Photos 1 and 2. The discharge of sediment laden water from the site is evidence that the City failed to use proper controls, structures, and management practices at the site that achieves best conventional treatment (BCT) for conventional pollutants. During the March 2, 2015 site inspection, the San Diego Water Board inspector observed a lack of effective erosion controls and runoff controls required by the CGP. Soil stabilization (e.g. soil tackifiers, hydroseed, etc.) technologies were not deployed in conjunction with runoff controls at the site. Without soil stabilization BMPs, in place, in addition to runoff controls the site did not meet BCT. See Attachment 1 – San Diego Water Board Facility Inspection Report dated March 2, 2015 Photos 1 through 16.

Photo 1: Mobilized sediment in storm water discharged from El Camino Real Road Widening Project. Sediment laden water flows along El Camino Real and across Tamarak. (view is north along El Camino Real at 0700 hours). Discharge from site boundary see Attachment No. 1 - 3-02-15 City of Carlsbad Incident Summary Photo at 0745 and 0930

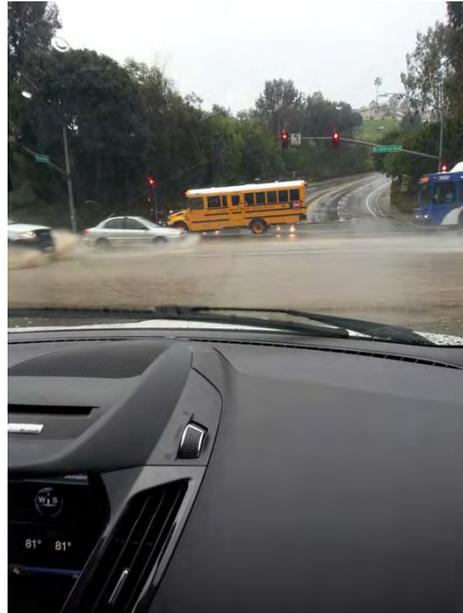
Photo 2: Evidence showing significant amount of sediment discharged from the site as seen in sediment laden spray from vehicles. This discharge flows downstream of Photo 1 and Photo 2 draining into Agua Hedionda Creek and Agua Hedionda Lagoon. (view is west along Tamarak with El Camino Real as the cross street at 0700 hours).

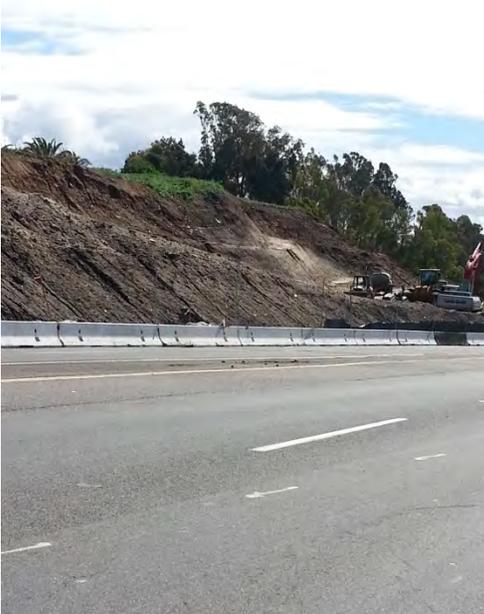
Photo 3: Project site located east of El Camino Real. Slopes unprotected from erosion. Soil stabilizer(s) not in place. Linear sediment controls not in place. (view is east along El Camino Real at the north end of the site at 1130 hours).

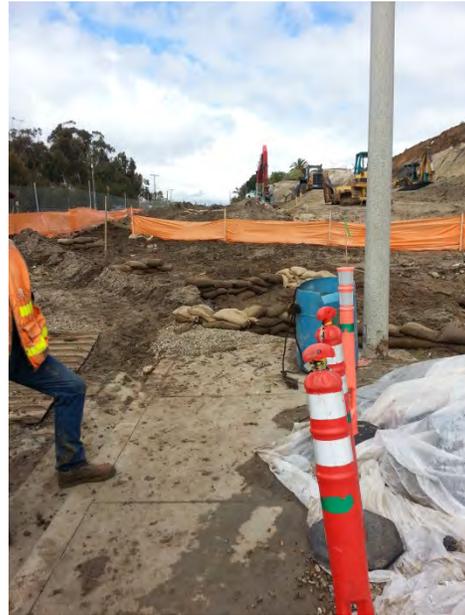
Photo 6: Check dams installed after rain event. Evidence of sediment discharged on the sidewalk. Discharge the result of lack of, insufficient amount, and ineffective installation of check dams and no silt fence prior to rain event. See Attachment No. 1 - 3-02-15 City of Carlsbad Incident Summary Photo at 0745 and 0930.

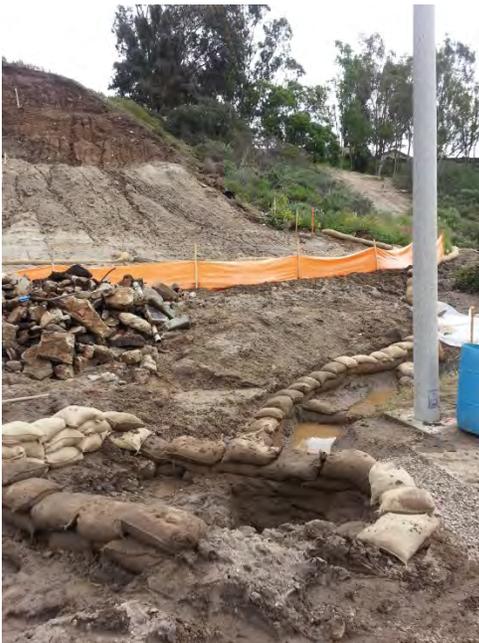
A sediment basin bermed with sand bags was in place at the downgradient end of the site located east of El Camino Real. Sediment basins are to be designed pursuant to CASQA Construction Stormwater BMP Handbook. The sediment basin on site was not present prior to the rain event and the one constructed on March 2, 2015 after the rain event was not designed in compliance with the CASQA Handbook. For before rain event see Photos at 0745 in Attachment 2 - March 2, 2015 City of Carlsbad El Camino Real Road Widening Project Incident Summary Report, Job 3957, WDID# 937C371534. For after rain event, see Attachment 1 - Photos 7 and 8.

Photo 7 Sedimentation basin constructed after rain event. See Attachment No. 1 - 3-02-15 City of Carlsbad Incident Summary Photo at 0745 and 0930 – sedimentation basin not installed) Sedimentation basin not designed in accordance with CASQA Construction BMP Guidance Handbook as required by CGP.

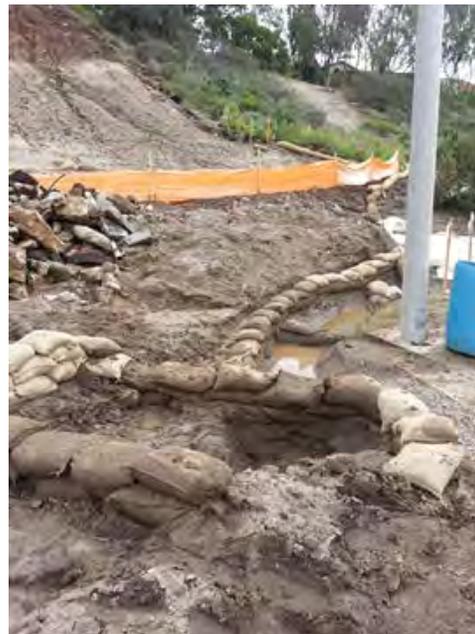
Photo 8: Sedimentation basin is extremely shallow and not designed in accordance with CASQA Construction BMP Guidance Handbook as required by CGP.

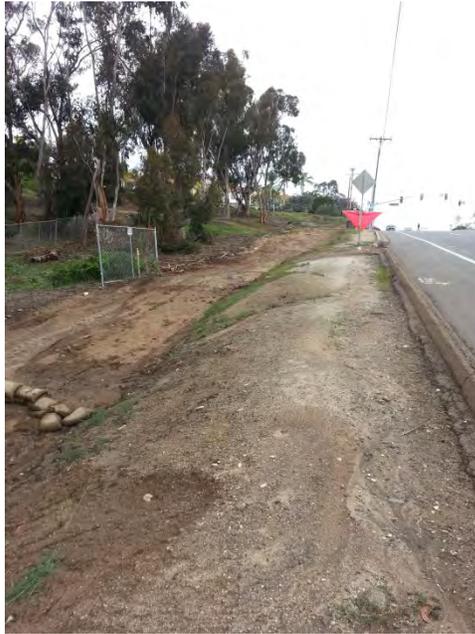
Photo 13 Lack of perimeter controls, lack of run-on controls, lack of erosion controls, lack of erosion controls in conjunction with sedimentation controls, and lack of soil stabilization controls. (view at north end of the site located on the west side of El Camino Real looking north).

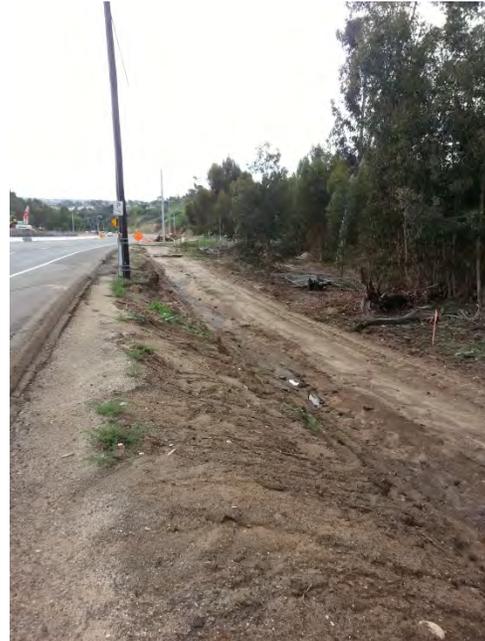
Photo 14 Lack of perimeter controls, lack of run-on controls, lack of erosion controls, lack of erosion controls in conjunction with sedimentation controls, and lack of soil stabilization controls. (view at north end of the site located on the west side of El Camino Real looking south).

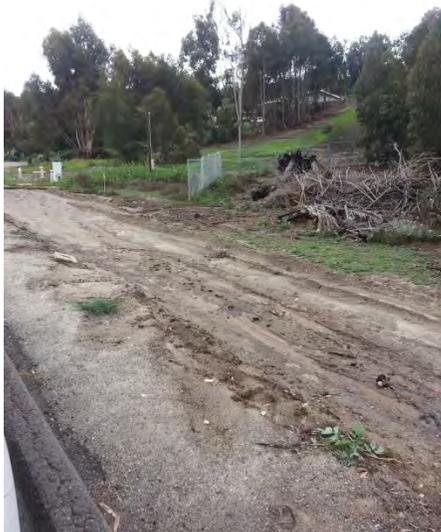
Photo 13 Lack of perimeter controls, lack of run-on controls, lack of erosion controls, lack of erosion controls in conjunction with sedimentation controls, and lack of soil stabilization controls. (view at south end of the site located on the west side of El Camino Real looking south toward inlet structure shown in Photo 16). This photo documents rilling evidence of erosion on this portion of the site due to an overall lack of perimeter controls, erosion and sedimentation controls.

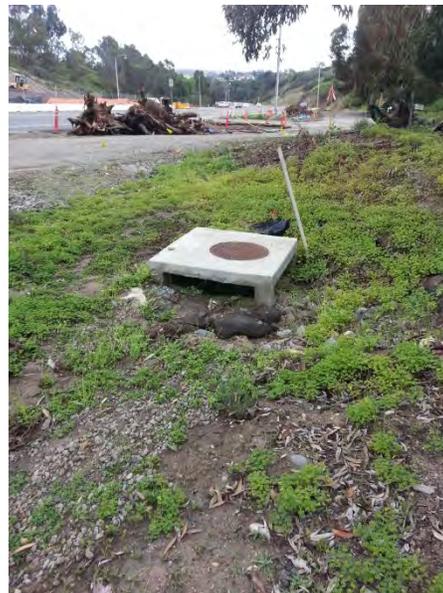
Photo 14 Unprotected inlet. This inlet is located directly down gradient of site shown in Photo 15. Erosion and sedimentation shown in Photos 13-15 are evidence of a discharge of sediment and sediment laden storm water to the MS4.

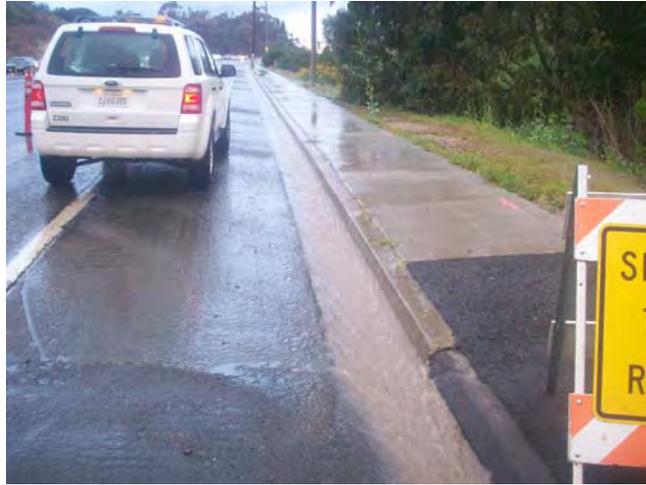
| Discharge flowing south on ECR from the project site. | | | |

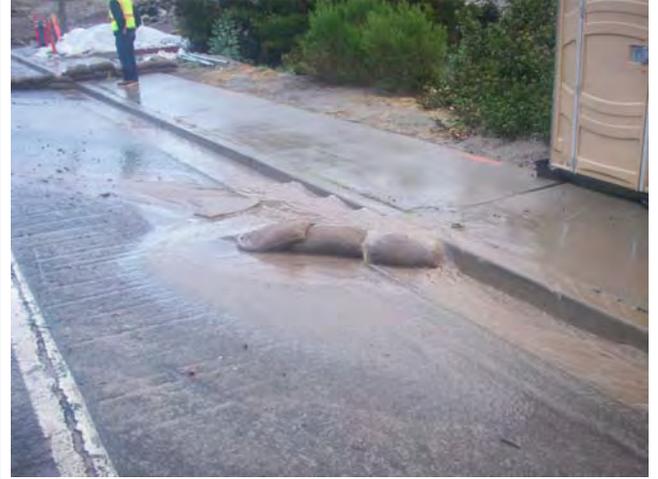
| Discharge flowing over and around chevrons on of ECR. | | | |

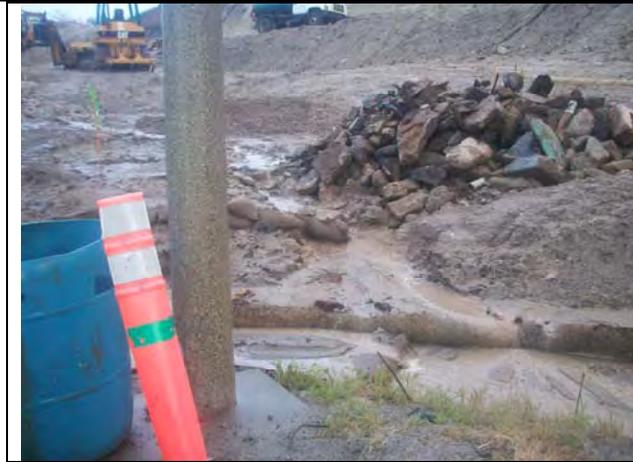
| Ineffective BMP placement resulted in several breaches throughout the site. | | | |

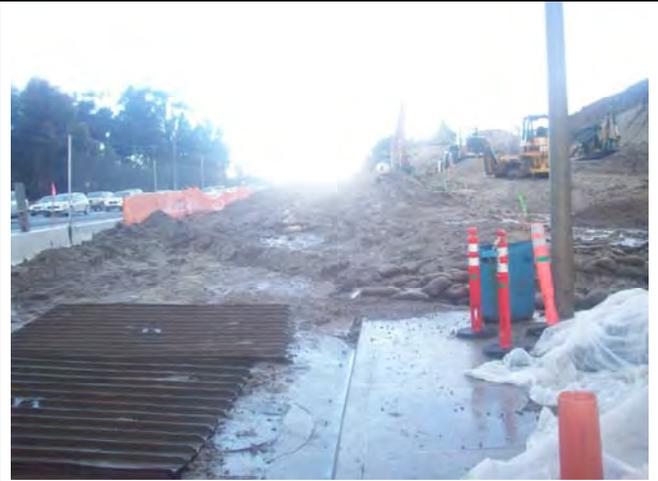
| Lack of BMP stockpiles throughout the site resulted in relocation of BMPs to breached areas. | | | |

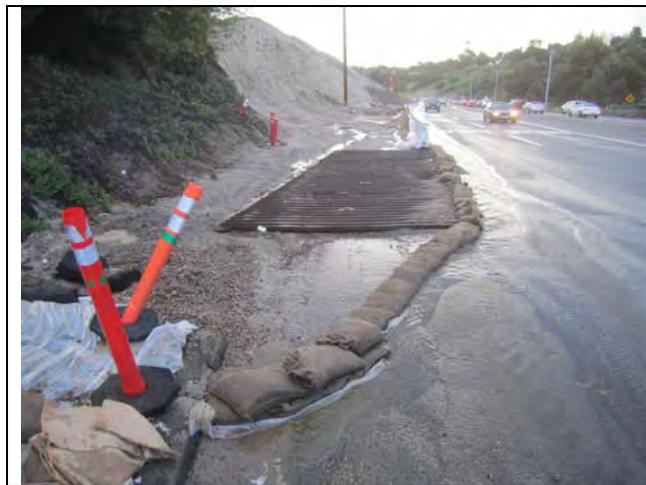
| Northernmost run-on protection where rainfall overwhelmed diversion and flowed behind K-Rail resulting in primary sediment discharge. | | | |

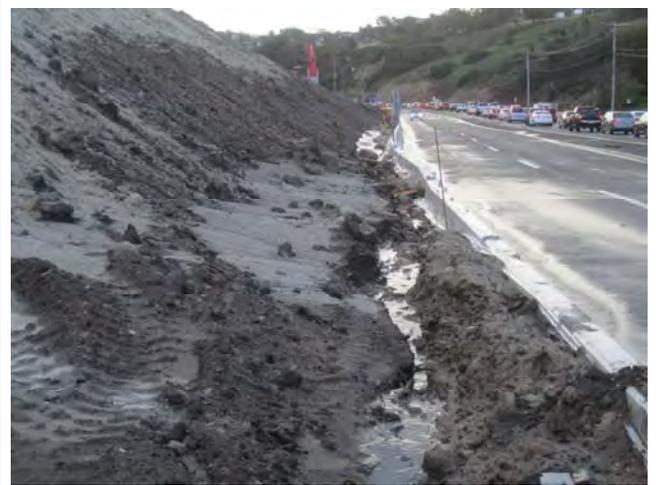
| Sediment accumulated behind K-rail from slope erosion. Resulted in sediment flowing out of K-rail lifting holes onto ECR. | | | |

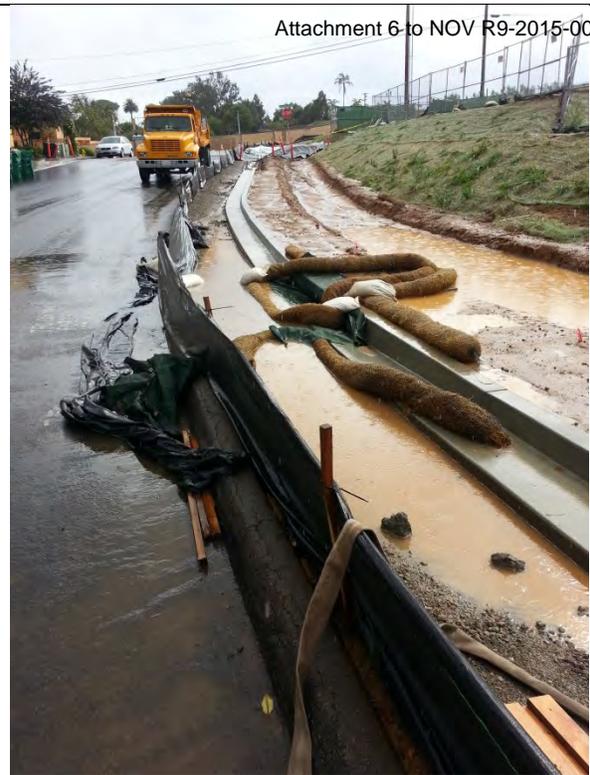
Buena Vista and James Dr. Photo 2

- 2) Failure to require good housekeeping practices per Order No. R9-2007-0001 Provision D.2.c(3) and maintenance of erosion and sediment control BMPs per Provision D.2.c(1)(a)x and Provision D.2.c(4). Photo 2 shows dilapidated silt fence and debris in the street as well as improper installation of fiber rolls around the storm drain inlet that is reportedly already connected to the MS4. The inlet was inundated with sediment laden water at the time of this inspection.

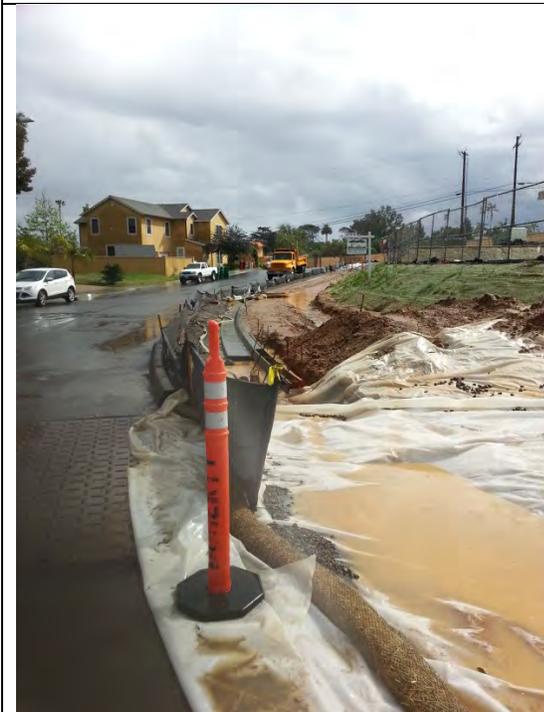
Buena Vista and James Dr. Photo 3

- 3) Failure to require proper perimeter control BMPs per Order No. R9-2007-0001 Provision D.2.c(1)(b)ii; Provision D.2.c(3) and Provision D.2.c(4). Photo 3 shows sediment on the exterior of the fiber roll indicating a discharge of sediment and sediment laden water from the site at an earlier point in the rain event. Photo 4 shows a small sump pump on the site apparently dewatering the low trench filled with sediment laden water and photo 2 shows the pipe draped over the silt fence with evidence of silt on the street just outside of the silt fence.

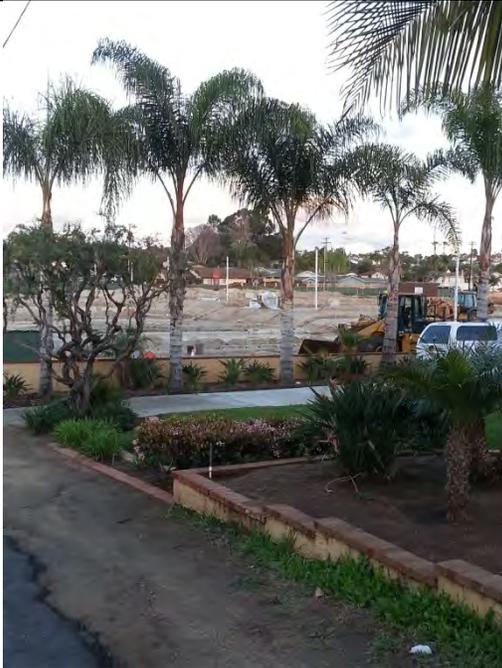
Photo 1- Construction with without erosion control present on interior slopes. Site discharges to Buena Vista Lagoon a 303d listed water body impaired for sedimentation.

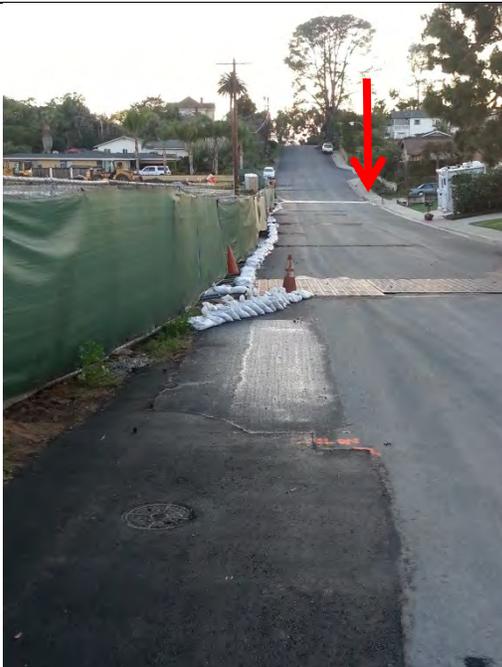
Photo 3- Tracks of sediment shown up and down Oak Ave. Discharge from the site shown by the yellow arrow.

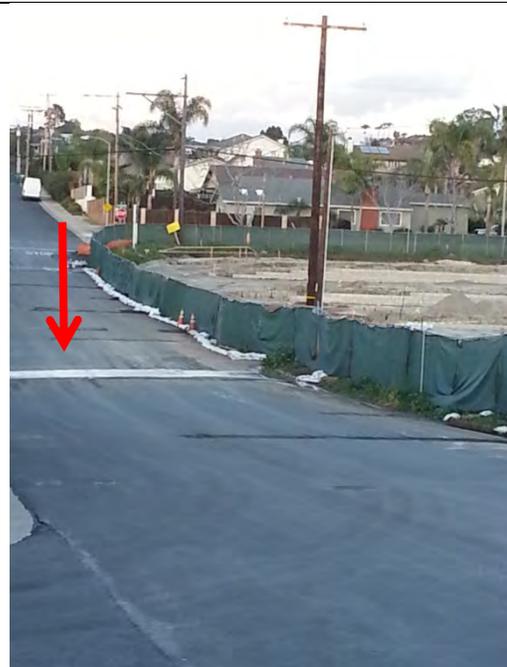
Photo 4 – Evidence of the flow path for discharges from the site to the MS4. Lack of soil stabilization, erosion controls, and sediment controls on the site as seen inside the fence. Stockpiles are not covered and no evidence of sediment or erosion control BMPs

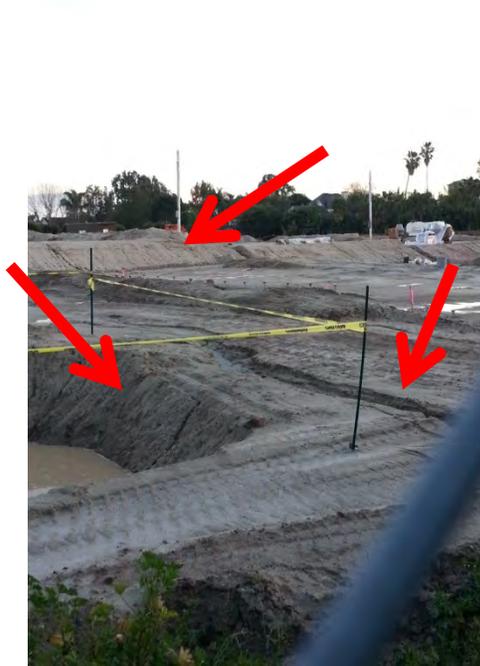
Photo 9 - Evidence of erosion on site. Large surface gullies present and significant erosion rills on slopes. Soil stabilization BMPs not present on site.
